Environmental Factors and Material Characteristics Influencing the Deterioration of the Nikka Stone in the Former Koshien Hotel

Tomoko Uno¹, Chisato Isoi¹, Chiemi Iba² and Koki Yamada²

¹ Department of Architecture, Mukogawa Women's, University, Nishinomiya, Japan

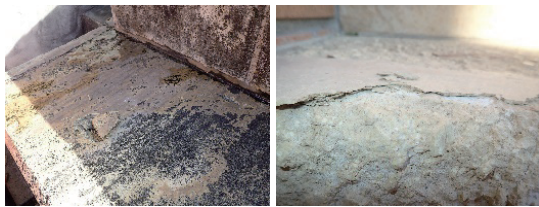
Numerous defects were evident in the Nikka stone’s horizontal plane, such as the coping stones and stair treads (Figure 4, left). The width of the defects ranged from a few centimeters to a dozen centimeters. The defects were approximately ten millimeters thick. Conversely, with the Tatsuyama stone, the deterioration like the flaking of few-millimeters-thickness on the horizontal and vertical surfaces of the stone beneath the eaves where there was little exposure to rain was observed (Figure 4, right). The deterioration was slight in the area not under the eaves, where the Tatsuyama stone becomes wet in rain.

Figure 4 Defects of the stone materials (left: Nikka stone, right: Tatsuyama stone)

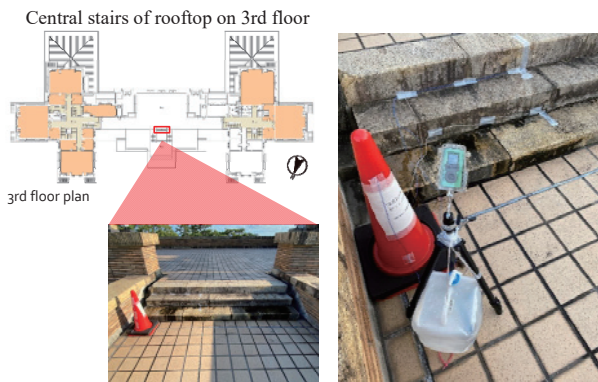
Figure 5 Nikka stone microenvironment survey (central stairs of rooftop on the third floor); the measured point in the 3rd floor plan (left) and condition (right)

The third-floor roof terrace was selected as the survey site for the Nikka stone. The measurement point was a north-facing staircase in the center of the terrace (Figure 5). There is no roof at this site, and hence, the horizontal surface of the staircase becomes wet quickly in rain. The stone in the upper part of the staircase has little deterioration; however, previously, cracks have been observed in stones in the lower part of the staircase (Uno & Noguchi, 2015, Isoi, 2021).

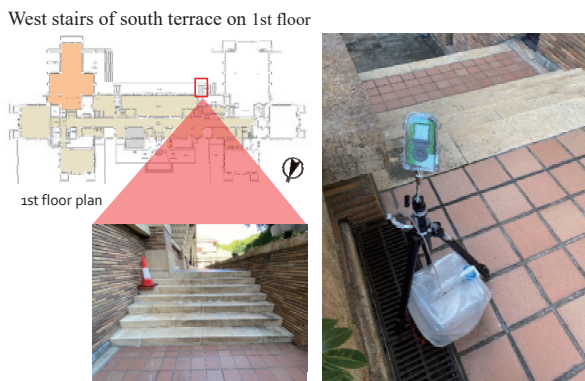
Figure 6 Tatsuyama stone microenvironment survey (south terrace west stairs on the first floor) the measured point in the 1st floor plan (left) and condition (right)

The west staircase of the south terrace on the first floor was selected as the survey site for the Tatsuyama stone. The Tatsuyama stone was measured on the west-facing staircase, which has eaves on the north side of the staircase (building side, left section of photo in Figure 6) and a deciduous tree and a low wall on the south side. There is a separate building on the west side. There are evident defects (flaking) under the eaves on the north side of the stairs; however, this rarely occurs at points that are not beneath the eaves.

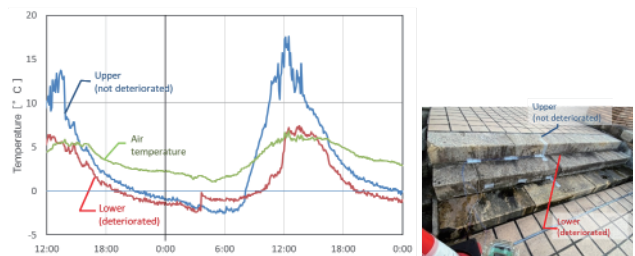
The surface temperature (Figure 7, left) was lower than the air temperature in both the upper stair (no deterioration) and lower stair (deteriorated) at night. This decline of the surface temperature the stairs is due to nocturnal radiation. During the day, the surface temperature in the upper stair was higher than the air temperature but equal to the air temperature in the lower stair. The differences in surface temperature can be attributed to the exposure to sunlight; the upper stair exposure to the sunlight throughout the day, whereas the exposure of the lower stair to sunlight is only in the afternoon. Here, it is reasonable to assume that, during the day, the temperature in the lower stair (deteriorated)—with less of sunlight and small storage of heat—does not increase much compared to that in the upper stair; thus, at night, the surface temperature of the lower stair also becomes lower than that of the upper stair.

Figure 7 Surface temperature of the deteriorated and not deteriorated Nikka stones (left) and measurement points (right)

From approximately 19:00 to 20:00 on December 31st 2020, (Figure 7 left), the temperature in both the upper and lower stairs was below the freezing point. The lower stair experienced a significant temperature spike of 2°C at 3:40 a.m. on January 1st 2021. This suggests that, after two days of rainfall, the internal water in the stone froze. Observations made a week later determined that cracking had progressed significantly.

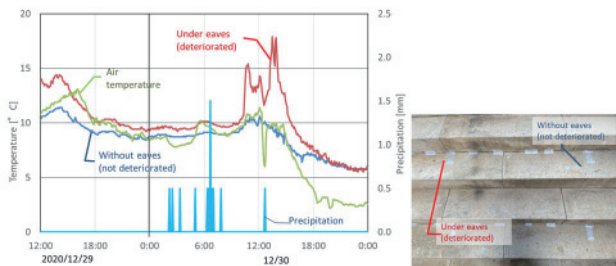
According to the measurement results (Figure 8, left), the temperature in the deteriorated area increased on sunny days where the area beneath the eaves was exposed to sunlight. The sound area without eaves was rarely exposed to direct sunlight because it was shaded on the south. Consequently, the temperature did not change significantly. At approximately 12:40 on December 30th, a brief period of precipitation occurred. At the deteriorated area under the eaves, the surface temperature varied by ~6°C before and after the rainfall. It was confirmed that rainfall and sunlight had a significant effect on the surface temperature at the deteriorated site. However, no temperature change was observed in the area without deterioration.

Figure 8 Surface temperature of the deteriorated and not deteriorated Tatsuyama stones (left) and measurement points (right)

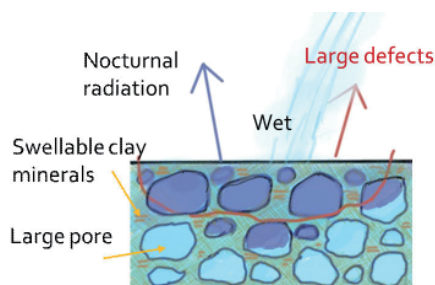
Figure 9 Deterioration mechanism of the Nikka stone

A diagram of the deterioration mechanism of the Nikka stone is presented in Figure 9. In this investigation, we found that significant deterioration occurred in areas where rainwater was easily absorbed, where the increase in temperature was small during the day, and where the temperature decreased at night due to nocturnal radiation. After a rainfall, the large pores in the Nikka stone contain water. When this water in the pores freezes, it expands and creates pressure, damaging the fragile parenchyma. The large defects are believed to be due to the formation of ice in the internal pores rather than on the surface of the stone.

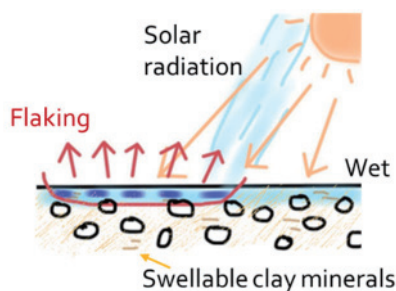
Figure 10 Deterioration mechanism of the Tatsuyama stone

A diagram of the deterioration mechanism of the Tatsuyama stone is presented in Figure 10. After moisture adsorption, internal absorption is slow. At damaged parts beneath the eaves, the wetness time caused by rainfall is short, and only a thin layer of the surface is wet. When the thin layer is exposed to the sun, the surface temperature of the stone varies significantly, and the surface become dry. The flaking only occurred near the surface because the thin surface layer would experience repeated wetting and drying.
