# Survey Report on the Areas Affected by the Earthquake with Epicenter in Southeastern Turkey

School of Architecture, Mukogawa Women's University, Japan

August 2023

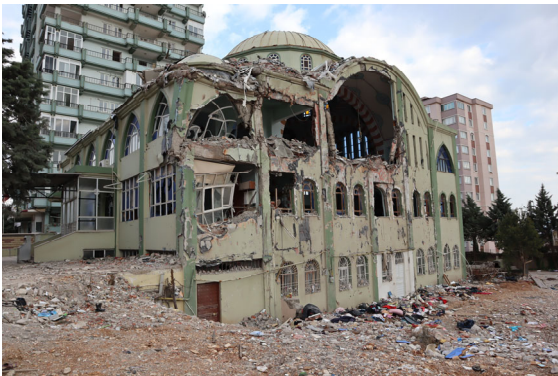
Photo 1-8 Onikişubat, K.Maraş.

HACI HUSEYİN KARA CAMARA CAMII.  
The building next door collapsed and damaged the Camii.

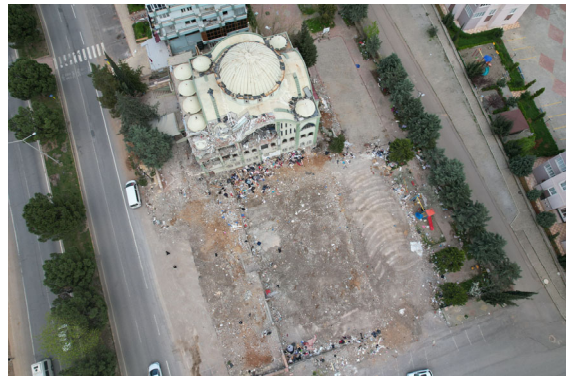
Photo 1-9 Onikişubat, K.Maraş.

HACI HUSEYİN KARA CAMARA CAMII.  
Shot from above by drone.

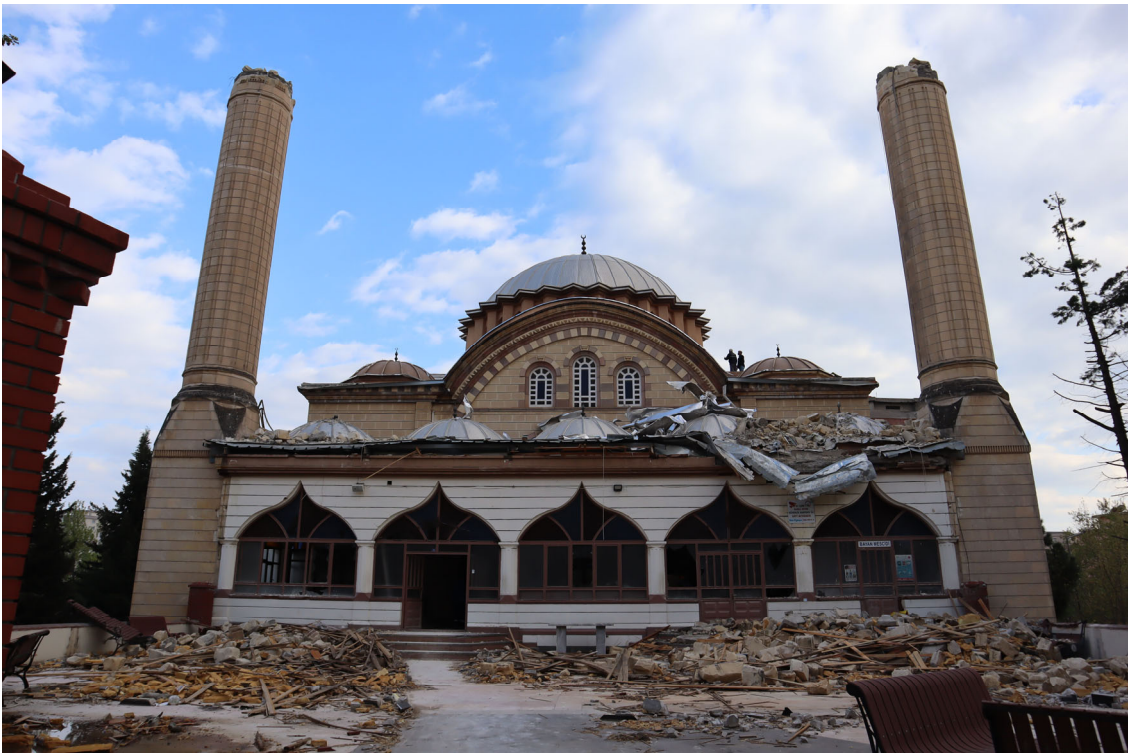
Photo 1-10 Onikişubat, K.Maraş. Hz. Yunus Cami. Collapse of minarets.

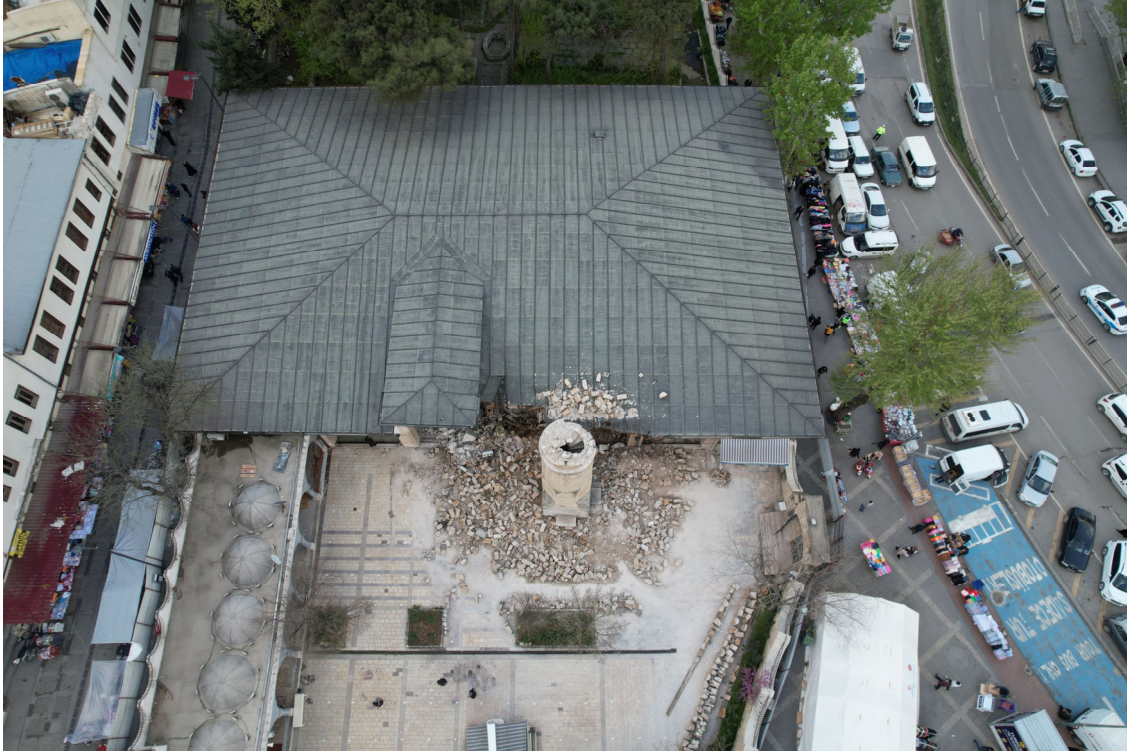
Photo 1-11 Dulkadiroğlu, K.Maraş. Drone shot of Ulu Camii.

The building below was damaged by the minaret breaking and falling stones.

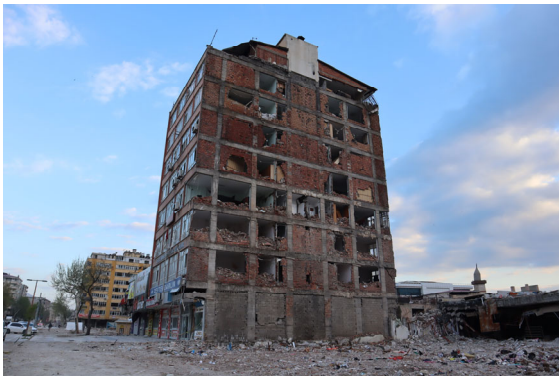
Photo 1-12 Dulkadiroğlu, K.Maraş.

Falling exterior wall blocks.

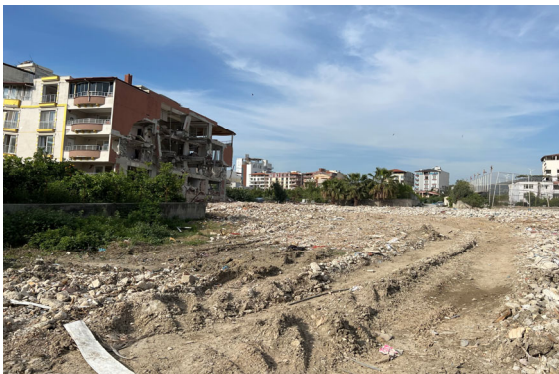
Photo 1-50 Samandağ, Hatay.  
Site where an extension building collapsed.

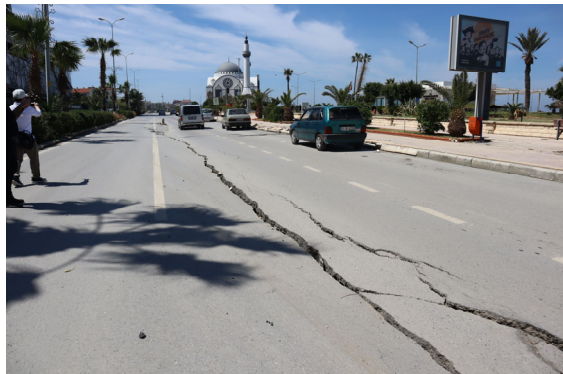
Photo 1-61 İskenderun, Hatay.  
Fissures in the ground

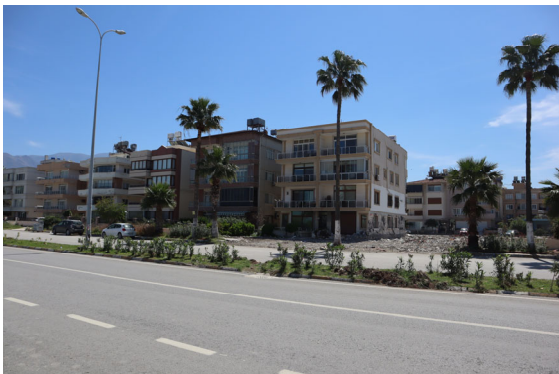
Photo 1-62 İskenderun, Hatay.  
A 9-story apartment building collapsed.  
4-story buildings are safe.

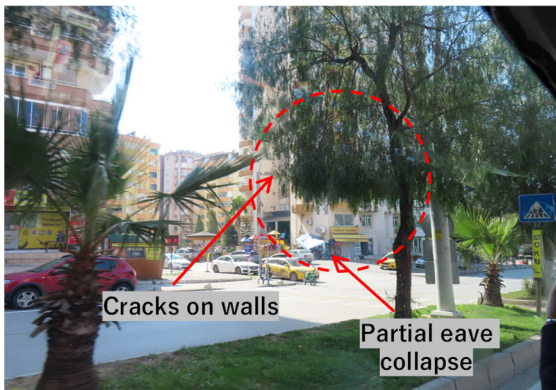
The seismic damages observed in the urban area of Adana are presented in Photo 2-1. This photograph captures the vicinity of the Cukurova municipal office, where numerous reinforced concrete (RC) high-rise apartment buildings line the main road. Cracks are discernible on the exterior walls of many buildings, constituting non-structural damages. Additionally, there is evidence of a partial eave collapse. However, during a cursory inspection of the urban area from a moving vehicle, no instances of building collapse resulting from the earthquake were observed. Nevertheless, as per a conversation with the headman of Cukurova and a news report from Japan, it has come to light that a 14-story RC apartment building suffered complete collapse as a consequence of the earthquake, as shown in Photo 2-2. Moreover, approximately 12 RC high-rise apartment buildings in Cukurova have also collapsed, which poses a critical issue. The precise locations of these collapsed apartment buildings have not been specified, making it challenging to accurately determine the intensity of the ground motions they were subjected to. However, presuming that the instrumental seismic intensity of the TK0118 and TK0123 observation stations in the Adana urban area is 3.7 and 4.0, respectively, a similar level of intensity can be inferred for these apartment buildings. It is postulated that critical design flaws contributed to the total collapse of the high-rise apartment buildings under this intensity level of ground motions.

Photo 2-1 Seismic damage in Adana

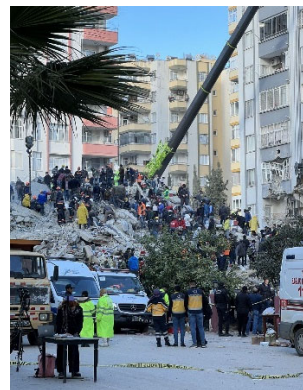
Photo 2-2 Collapse of 14-story apartment

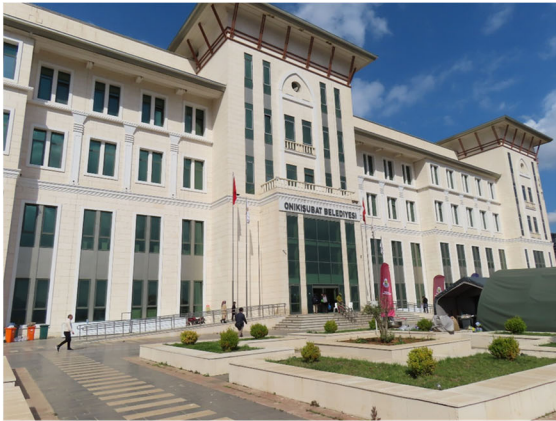
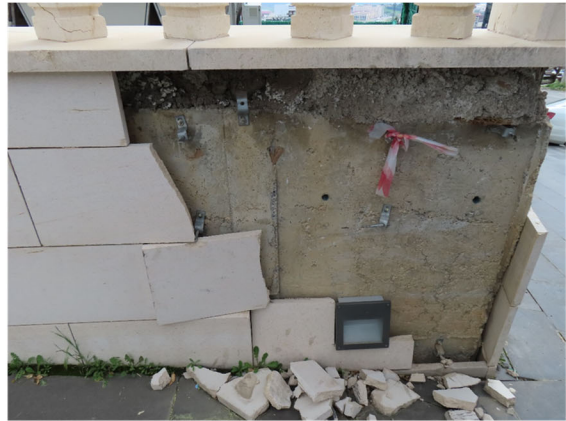
The seismic damages resulting from the earthquakes at the six locations (① to ⑥) visited during the survey in the urban area of Kahramanmaras are presented in Photo 2-3 to 2-8. These six locations are illustrated in Fig. 2-6. The damage conditions at locations ① and ② are described. Location ① is where the Onikisubat municipal office is situated. Location ② is in close proximity to the observation station TK4617 and is believed to have experienced ground motions with an instrumental seismic intensity of approximately 4.7. As shown in Photo 2-3 on the left, the four-story RC building of the Onikisubat municipal office does not exhibit any structural damage. However, as shown in Photo 2-3 on the right, a portion of the dry external wall has collapsed. At the location ②, near the Onikisubat municipal office, as seen in Photo 2-4 in the left, recently constructed high-rise apartment buildings stand side by side. Concrete walls without reinforcements have fallen in an out-of-plane direction. Additionally, as shown in Photo 2-4 on the right, exterior walls have collapsed towards the entrance. If individuals had been present at the time of the collapse, severe human casualties would have occurred. Generally, at Locations ① and ②, while structural members may have experienced damages, non-structural members, such as exterior wall damage, are more prominent.

Photo 2-3 Seismic damage in Kahramanmaras (Location ①)

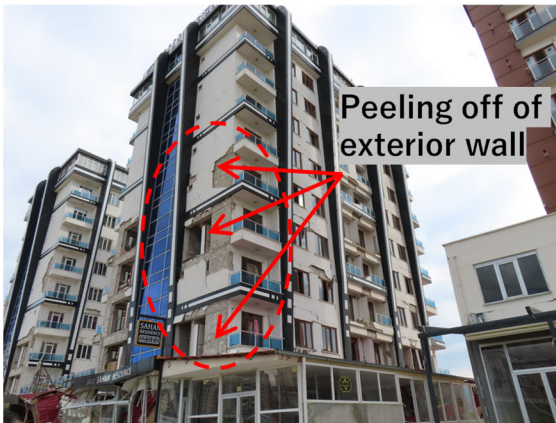
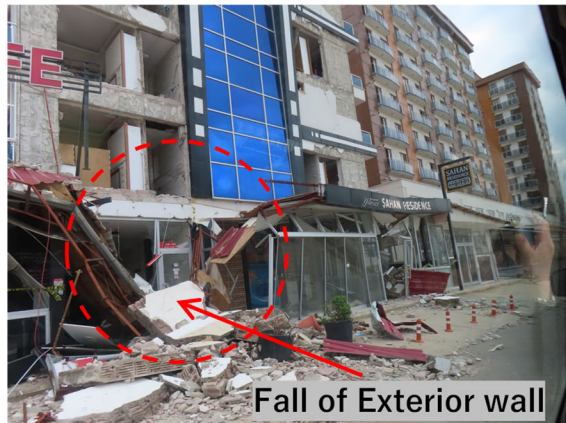
Photo 2-4 Seismic damage in Kahramanmaras (Location ②)

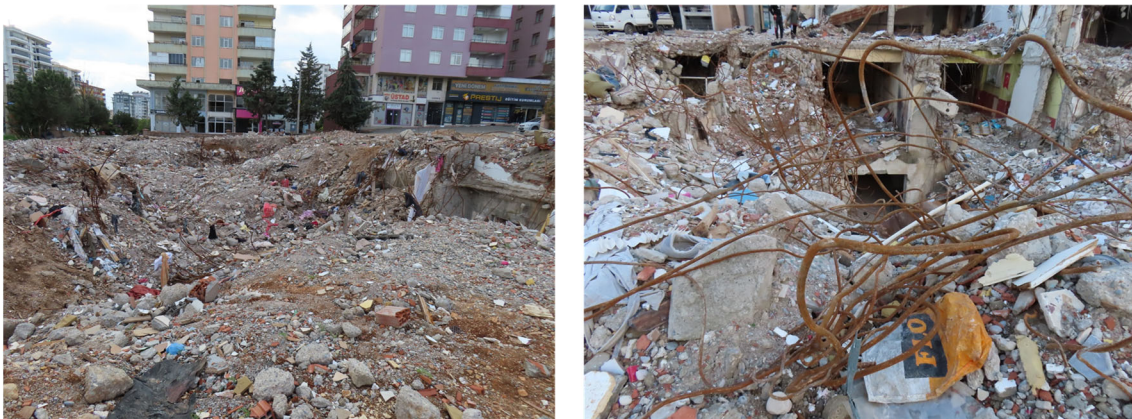
It is postulated that Locations ③ and ④ experienced ground motions with an instrumental seismic intensity of approximately 5.0, given their proximity to observation station TK4620. At Location ③, three ten-story residential complexes underwent structural collapse, and as shown in Photo 2-5 on the left, debris had been cleared, leaving cleared construction sites. There was scarce evidence available to ascertain the causes and types of the building collapses. Nevertheless, steel reinforcements of considerable diameter were discovered protruding from the ground as shown in Photo 2-5 on the right, which were presumed to be main reinforcements at the lower levels. Both deformed and round steel reinforcements were identified. The influences of round steel reinforcements as a contributing factor to the building collapse cannot be definitely determined. However, the AIJ standard for the structural calculation of reinforced concrete structures specifies that primary reinforcements should be deformed reinforcements exceeding a diameter of D13, as stated in Article 13, and that more than four primary reinforcements should be deformed reinforcements with a diameter greater than D13, as outlined in Article 14. A few buildings suffered complete collapses, while concurrently, as shown in the background of Photo 2-5 on the left, numerous medium and high-rise structures appear to have withstood the event without any discernible structural damage, based on their external appearance. At Location ④, as shown in Photo 2-6 on the left, the upper portion of a minaret belonging to the Yunus Cami Mosque collapsed, and as shown in Photo 2-6 on the right, stacked stones plummeted to the ground or onto the mosque's roof. It is worth noting that Location ④ is nearly indistinguishable from the ground motion observation station TK4620.

Photo 2-5 Seismic damage in Kahramanmaraş (Location ③)

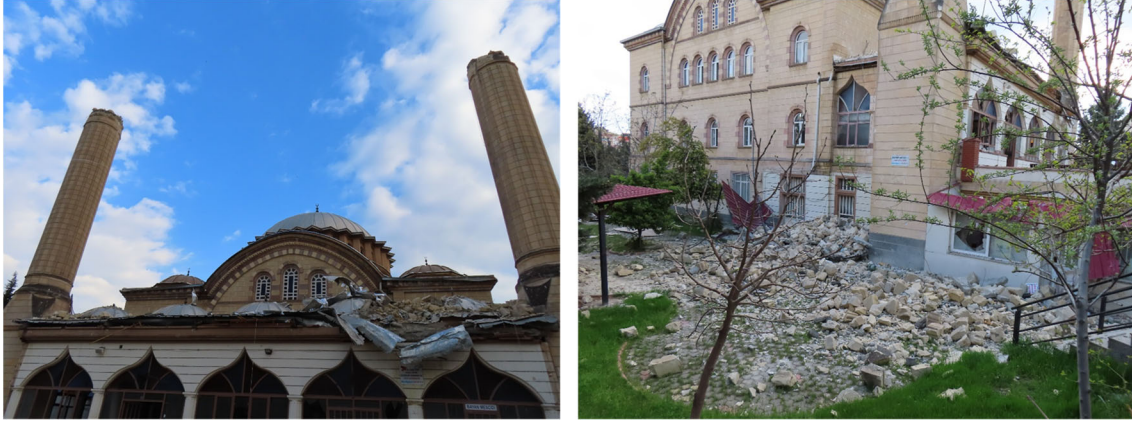
Photo 2-6 Seismic damage in Kahramanmaras (Location ④)

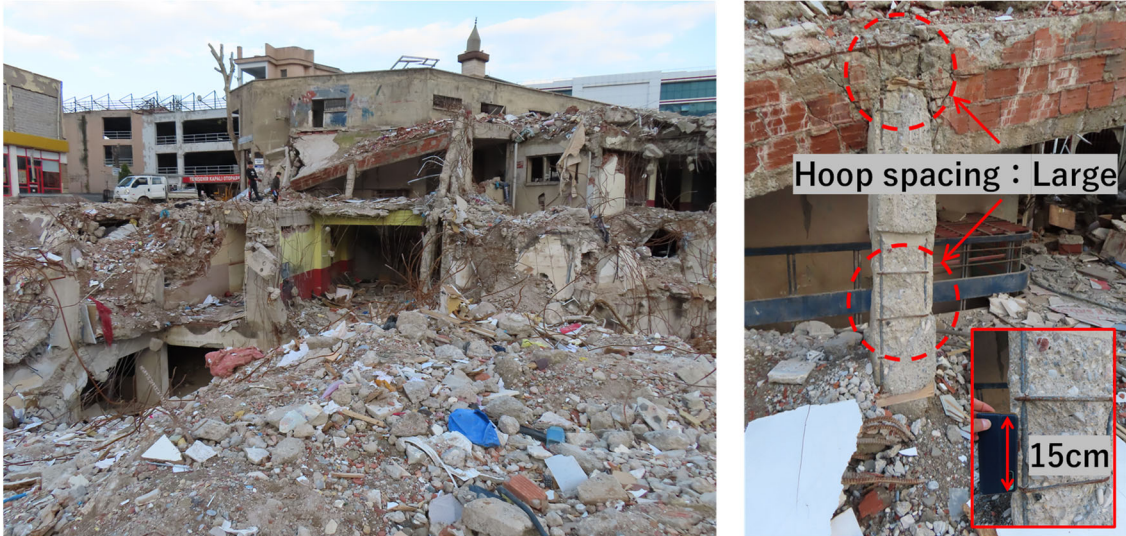
Locations ⑤ and ⑥ experienced exceptionally severe seismic damage within the urban area of Kahramanmaras, as shown in Photo 2-7 on the left, presenting a profoundly devastating state throughout the district. These locations, in close proximity to observation station TK4620, exhibited significantly more extensive seismic damage compared to the district encompassing Locations ③ and ④. While it is postulated that this disparity could be attributed to unfavorable soil conditions leading to seismic amplification and the dense arrangement of commercial and residential buildings, quantitatively verifying these factors may prove challenging. At Location ⑤, as shown in Photo 2-7 on the right, a column with substantial spacing between hoops, which serve as shear reinforcements, was observed. Although the hoops should have been more densely arranged around the beam-column joint, they were spaced widely, resembling the configuration seen in the central section of a beam.

Photo 2-7 Seismic damage in Kahramanmaras (Location ⑤)

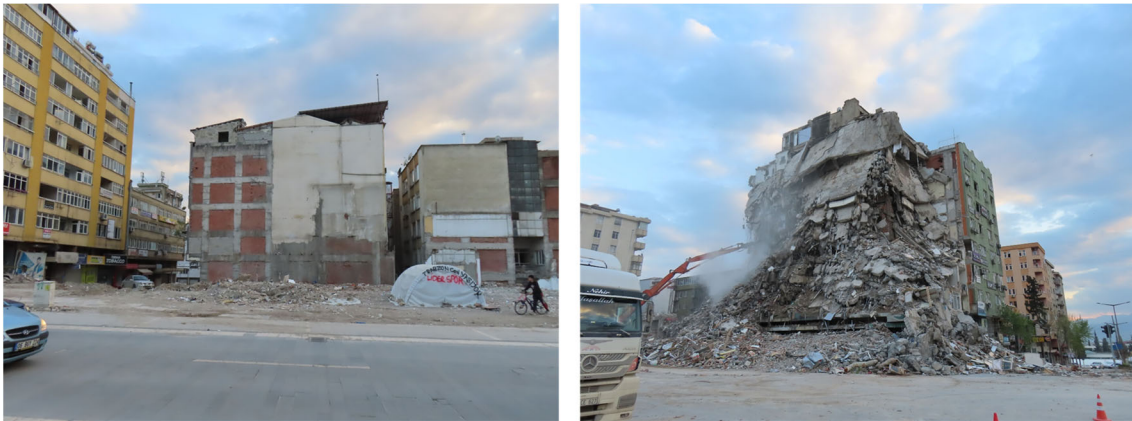
At Location ⑥, as shown in Photo 2-8, a bustling downtown area characterized by a dense congregation of commercial and residential structures along major thoroughfares suffered extensive building collapses. In many buildings, the ground floor consists of shops, while the stories above the second-floor house residential units. The shops on the ground floor feature large openings, resulting in an eccentricity in the stiffness distribution across the height of the structures. Moreover, the building layout itself exhibits significant eccentricity due to the protrusion of balconies and the irregular arrangement of columns and walls. It is conjectured that such an imbalance in the overall structural system contributed to the collapses, emphasizing the importance of considering stiffness distributions across the height and the building plan, as well as the fundamental concept of seismic design, including the utilization of designated design routes such as routes 2 and 3 employed in Japan.

Photo 2-8 Seismic damage in Kahramanmaras (Location ⑥)

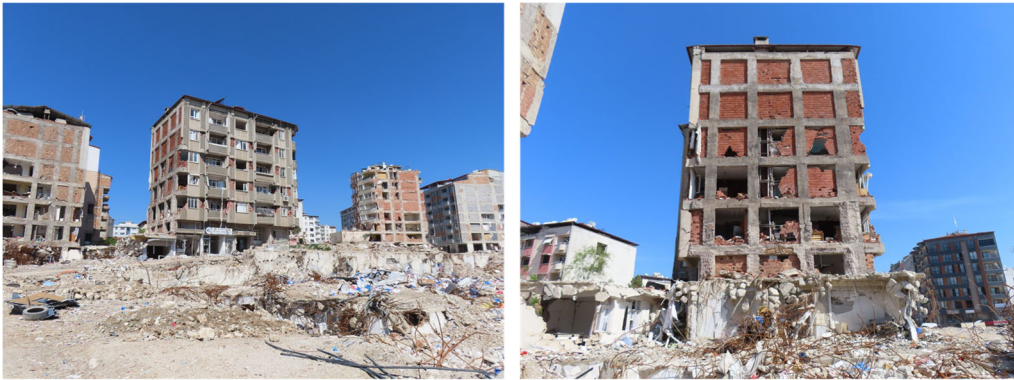
Photos 2-9 and 2-10 illustrate the seismic damage observed in the new and old urban areas of Antakya, respectively. The locations visited and surveyed in both the new and old urban areas of Antakya are indicated in Fig. 2-14. In the new urban area of Antakya, as shown in the left image of Photo 2-9, numerous medium- and high-rise reinforced concrete (RC) building structures suffered collapses, with debris having been cleared from the sites. In the right image of Photo 2-9, even among the standing buildings that did not collapse, the exterior brick walls experienced significant out-of-plane displacement, resulting in substantial damage and a ruinous appearance. The specific structural distinctions between the collapsed and non-collapsed buildings are not clearly evident. Notably, the left image of Photo 2-9 reveals that the non-collapsed buildings exhibit a predominantly regular configuration, with beam and column moment-resisting frames being prominently featured. Moving forward, it is imperative to elucidate the mechanisms and factors contributing to the collapses of the affected buildings.

Photo 2-9 Seismic damage in Antakya new urban area

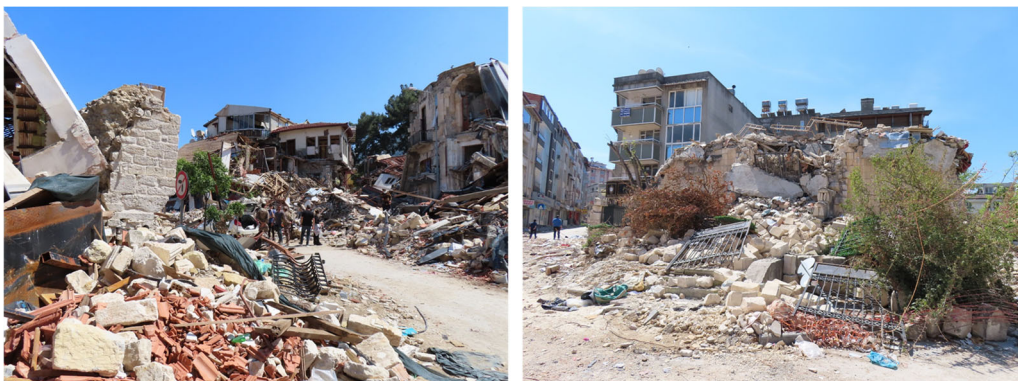
Conversely, in the old urban area of Antakya, as shown in Photo 2-10, numerous masonry structures constructed with stones and bricks suffered collapses. Additionally, some wooden structures also experienced failures. Debris still remains at the sites. It is noteworthy that the stacked stones and bricks slipped due to the seismic forces and furthermore, slipped due to the overturning moments, known as P-Delta effects, leading to loss of stability and cascading collapse. Considering this, the structural integrity throughout the height of masonry structures is of paramount importance.

Photo 2-10 Seismic damage in Antakya old urban area

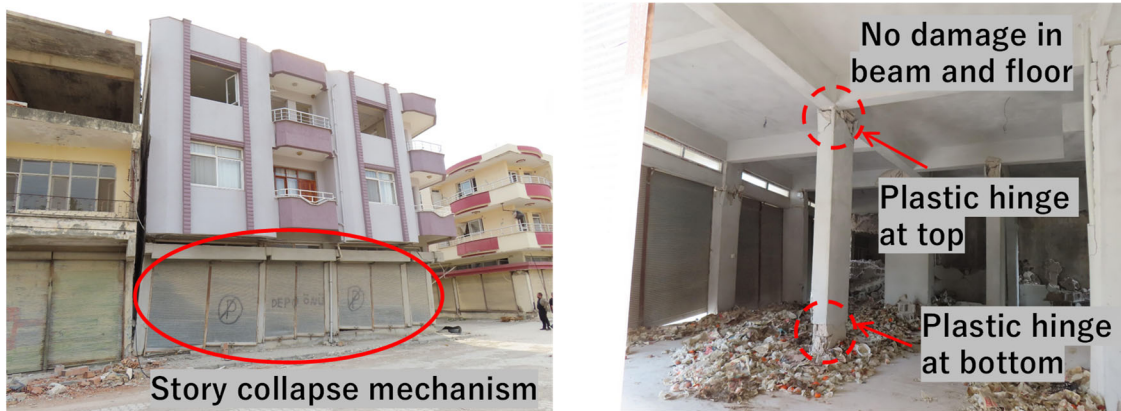
The seismic damage observed in Samandag is shown in Photo 2-11. Within the residential district of Samandag, a three-story apartment building experienced a collapse with the story mechanism. While the second and third stories sustained minimum damage, as evident from the spacing between adjacent buildings, the first story exhibited a significant inclination. This phenomenon can be attributed to the distinctive weak-story collapse mechanism, wherein the drift is concentrated in the first story. This is clearly the weak-story collapse mechanism with the drift concentration in the 1<sup>st</sup> story. As shown in the right image of Photo 2-11, plastic hinges formed at the top and bottom of the columns within the first story, leading to the occurrence of the story collapse mechanism. Conversely, the beams and floors remained largely undamaged. It is imperative to consider global collapse mechanisms that prioritize beam yielding before column yielding, accounting for the relative strengths of the columns and beams, or employ multi-story seismic walls to mitigate the occurrence of the story collapse mechanism.

Photo 2-11 Seismic damage in Samandag

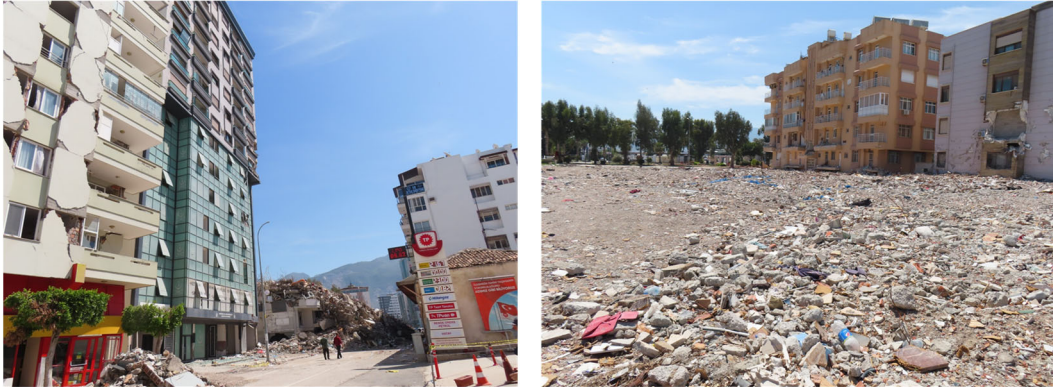
In the urban area of Iskenderun, as shown in the left image of Photo 2-12, tall apartment buildings collapsed in their entirety. Numerous cracks marred the walls of these high-rise structures, resulting in significant damage, and it appeared that the entire structures exhibited a slight inclination. These sites are situated along the coastline, and it is evident that liquefaction played a role in these occurrences. Among them, three medium- and high-rise apartment buildings experienced a pancake-style collapse. As shown in the right image of Photo 2-12, the debris had already been cleared, leaving cleared construction sites. The pancake collapse entails a progressive sequence of failures, wherein certain structural members succumb to the earthquake-induced shaking, subsequently causing a chain reaction that leads to the failure of other members, resulting in an overall loss of structural stability. One common characteristic among these collapses is the absence of redundancy. It is highly desirable to incorporate redundant design principles, wherein additional members that remain intact during seismic events

are implemented or other members possess the capacity to bear the load, even if one member fails.

Photo 2-12 Seismic damage in Iskenderun

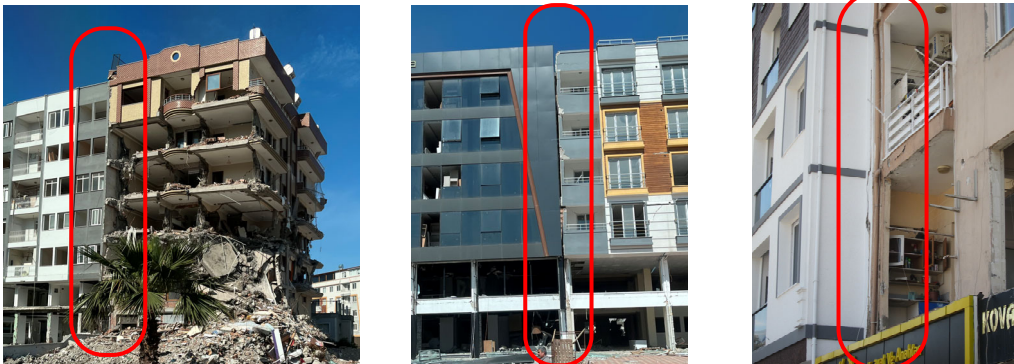
The seismic forces occurring in individual buildings are designed under the assumption that each building bears its own load. However, in urban areas of Turkey, where building walls are located on property boundaries and adjacent buildings are closely attached, it is believed that a cluster of buildings within a city block behaved as a unified entity in response to seismic horizontal motion. On the other hand, the construction periods of individual buildings vary, and it is speculated that there were buildings with insufficient seismic resistance considering the current seismic standards. Therefore, it is presumed that the seismic horizontal forces of the interconnected cluster of buildings led to concentrated destruction in certain buildings, and further, the horizontal forces concentrated on the next building, resulting in a chain reaction of destruction and the expansion of damage.

Photo 3-1 Adjacent buildings in close contact

When buildings are in close proximity, there is a higher risk of chain collapse, where buildings with different vibration characteristics or seismic resistance interact and collapse together. Therefore, it is necessary to provide spacing between adjacent buildings to prevent collision in the event of horizontal displacement caused by seismic forces. However, achieving this while maintaining the plot ratio can be challenging. One potential solution is the integration of adjacent buildings, although this raises issues related to land ownership and usage rights. By integrating buildings, two adjacent columns that would be in close proximity can be merged into a single larger column, and two adjacent infill walls can be combined into a single seismic wall, resulting in a highly seismic-resistant structure. Additionally, shared facilities such as stairs and elevators can be rationalized and used.

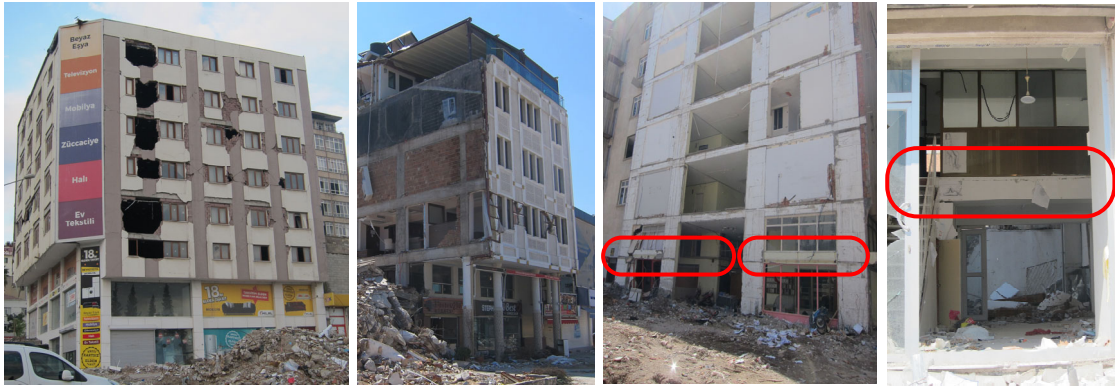
Photo 3-2 Buildings with Commercially Used Lower Levels and Mezzanine Floors

In the case of high-rise and mid-rise buildings in urban areas of Turkey. The lower levels are predominantly used for commercial purposes. As a result, the lower levels often lack walls and some have mezzanine floors with high ceilings. Furthermore, to create open storefronts facing the streets, the column width in the direction of the storefront is narrow. Consequently, the lower levels exhibit lower stiffness in the direction facing the street, leading to a structural configuration (commonly known as piloti system) where seismic energy tends to concentrate in the lower levels, resulting in damage. Additionally, the column width is wide in the depth direction but narrow in the storefront direction (same as the beam width), which makes the structure prone to column bending yielding and collapse in the storefront direction. It is presumed that damage occurred due to this type of rigid-jointed structure. It is worth noting that the current Turkish seismic design code, TBEC-2018, includes considerations for non-uniform horizontal stiffness and mezzanine floors.

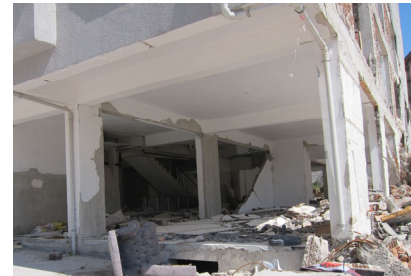
Photo 3-3 Column Flattened in the Storefront Direction

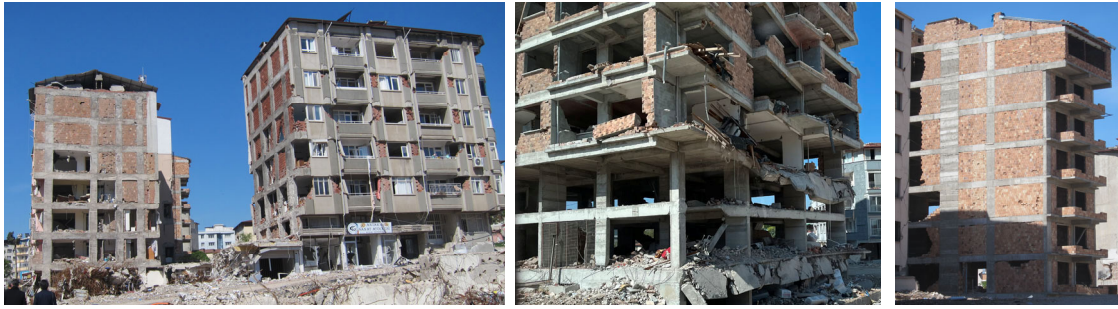
Based on the observation of the remaining buildings, collapsed buildings' debris, or buildings under construction in urban areas of Turkey following the earthquake, it can be seen that the high-rise reinforced concrete (RC) buildings have RC rigid-jointed structures, with external and internal walls made of unreinforced insulated concrete blocks or brick masonry. Consequently, these buildings were unable to follow the inter-story displacement of the RC rigid-jointed structures during the earthquake. They collapsed or suffered partial collapses and dislodgment prior to the structural collapse, leading to an increased risk of casualties.

Photo 3-4 The Damaged RC Buildings (Left) and Under-Construction RC Buildings (Center/Right)

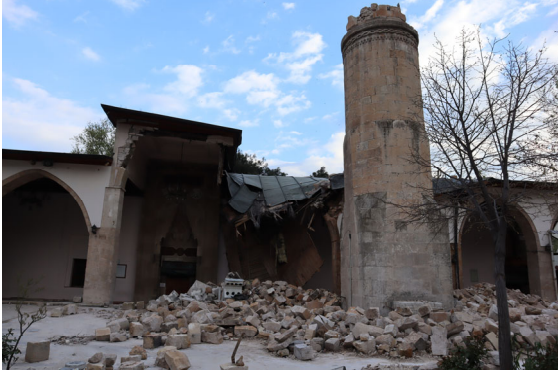
Photo 5-1 The minaret collapsed and stones were lying on the ground. The entrance area was damaged.

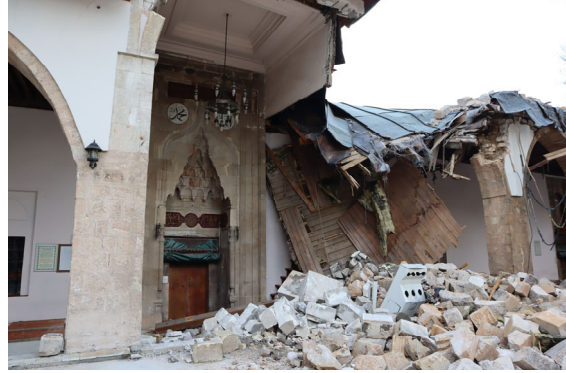
Photo 5-2 The entrance area was damaged.

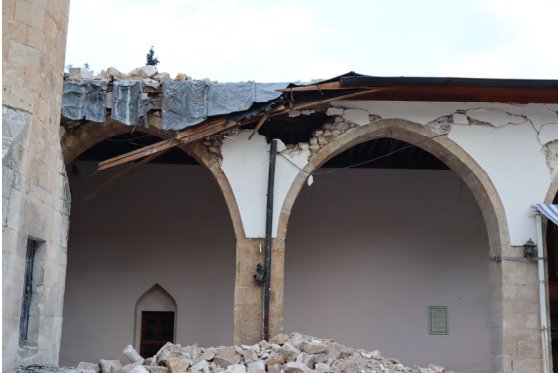
Photo 5-3 Damaged portico.

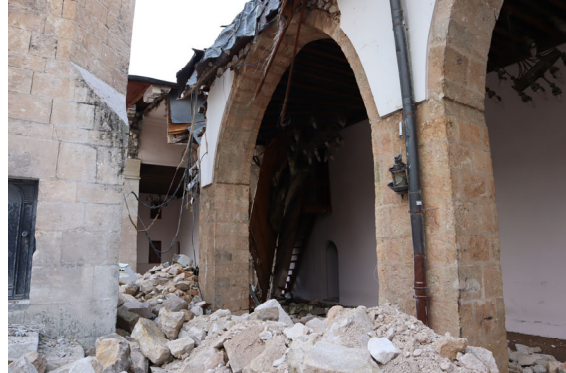
Photo 5-4 Damaged portico.

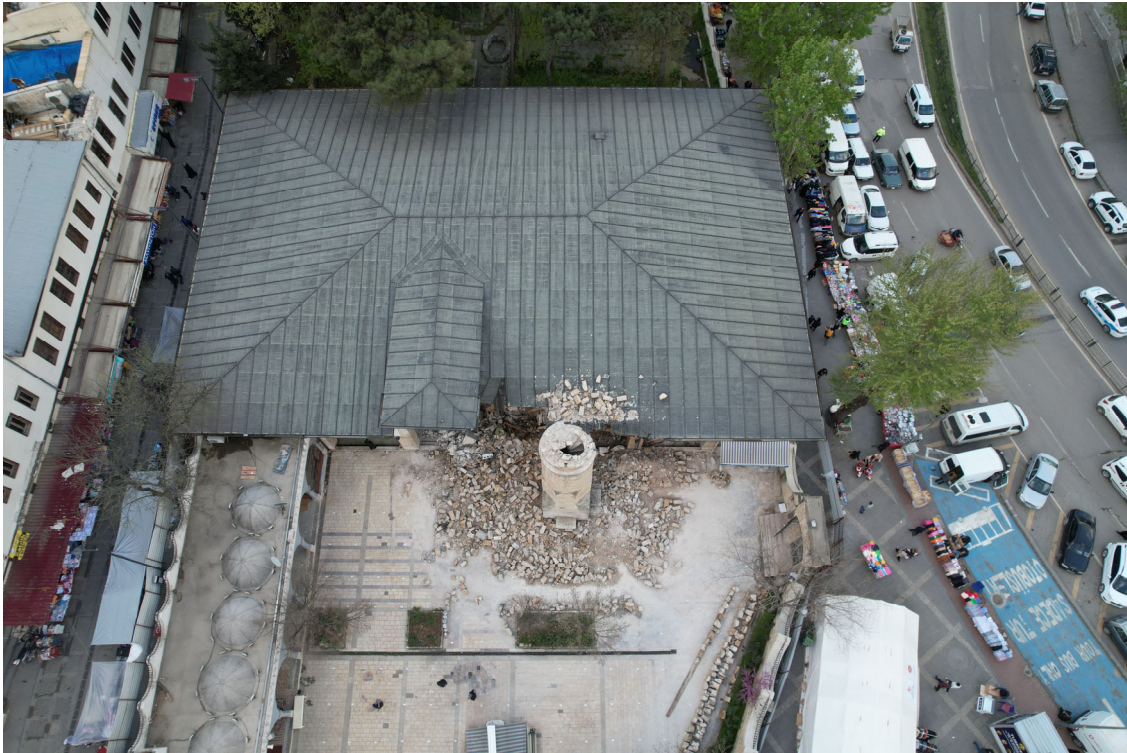
Photo 5-12 The building was damaged by the minaret collapsing and falling stones.

In all of the traditional mosques that we were able to inspect, the minarets had collapsed. In addition, in the Kahramanmaraş Ulu Camii, it was confirmed that the building was damaged due to collapsed minarets. The development of seismic reinforcement methods for masonry structures is urgently needed to protect cultural heritage buildings, and among them, the promotion of seismic reinforcement of minarets is expected to have a very immediate effect in protecting cultural heritage buildings.

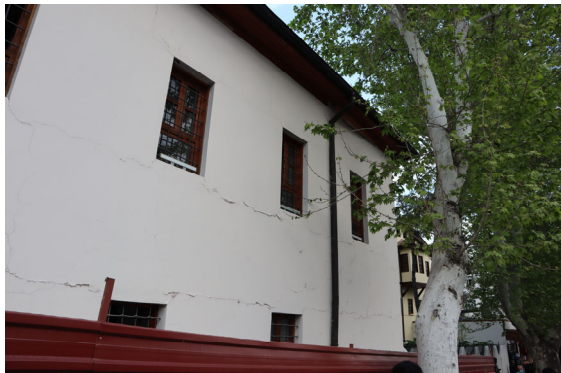
Photo 5-16 Cracks in exterior wall.

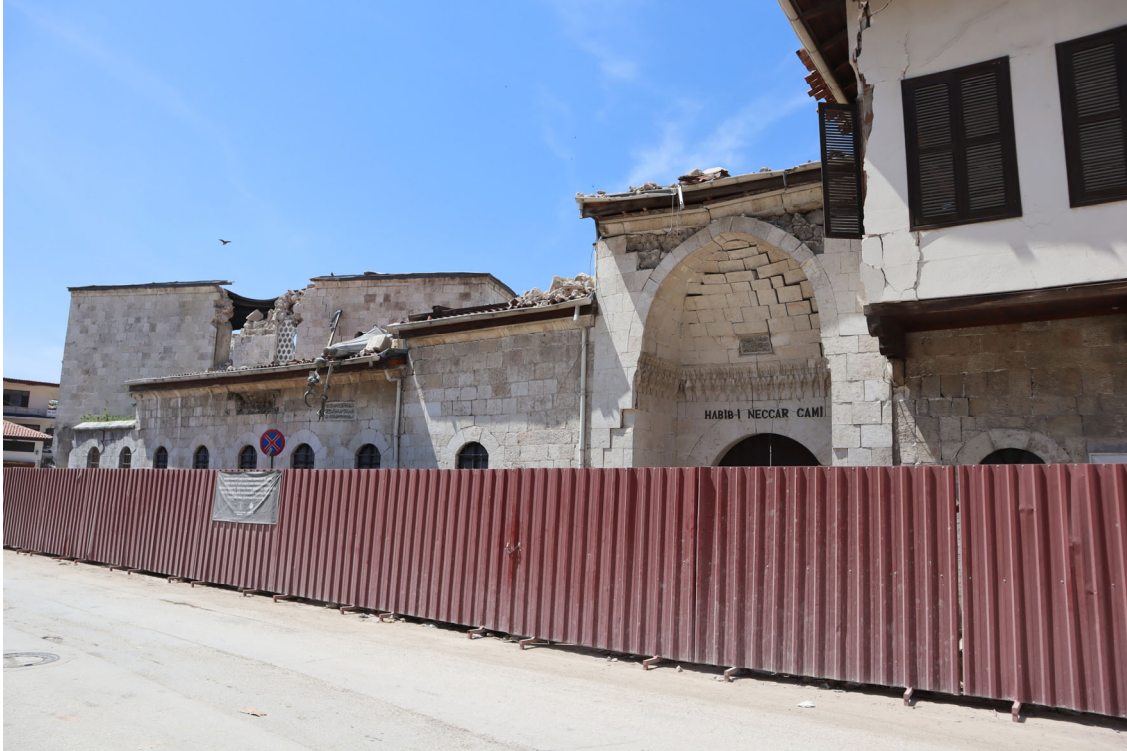
Photo 5-22 Antakya, Hatay. Habib-i Neccar Camii  
The minaret and dome collapsed.

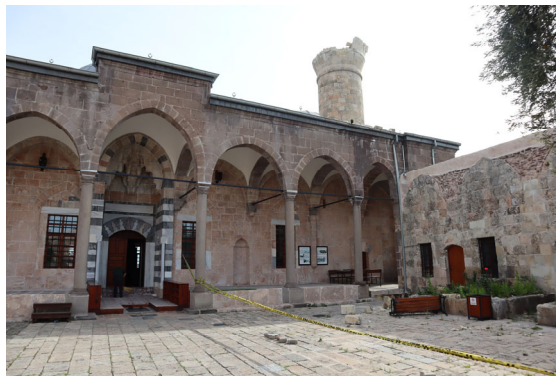
Photo 5-25 Payas, Hatay. Sokullu Mehmet Paşa Külliyesi designed by Mimar Sinan.  
The minaret collapsed.
