「トルコ共和国における歴史的市街地の復興に関する国際貢献事業」

# 報告書

武庫川女子大学

2024年3月

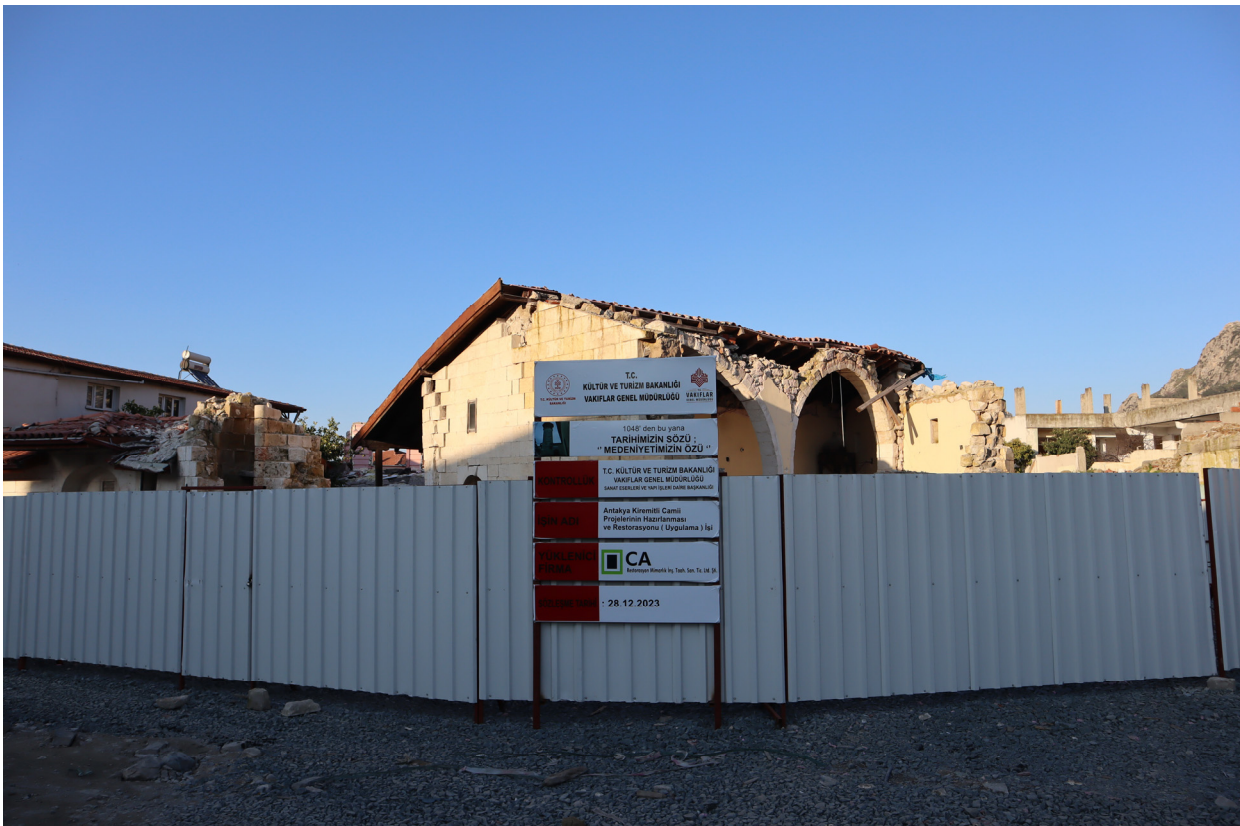
壊れたジャーミィ (=モスク) は、国が必ず仮囲いをしている。囲いのみで、修復はまだ始まっていないものが多い。

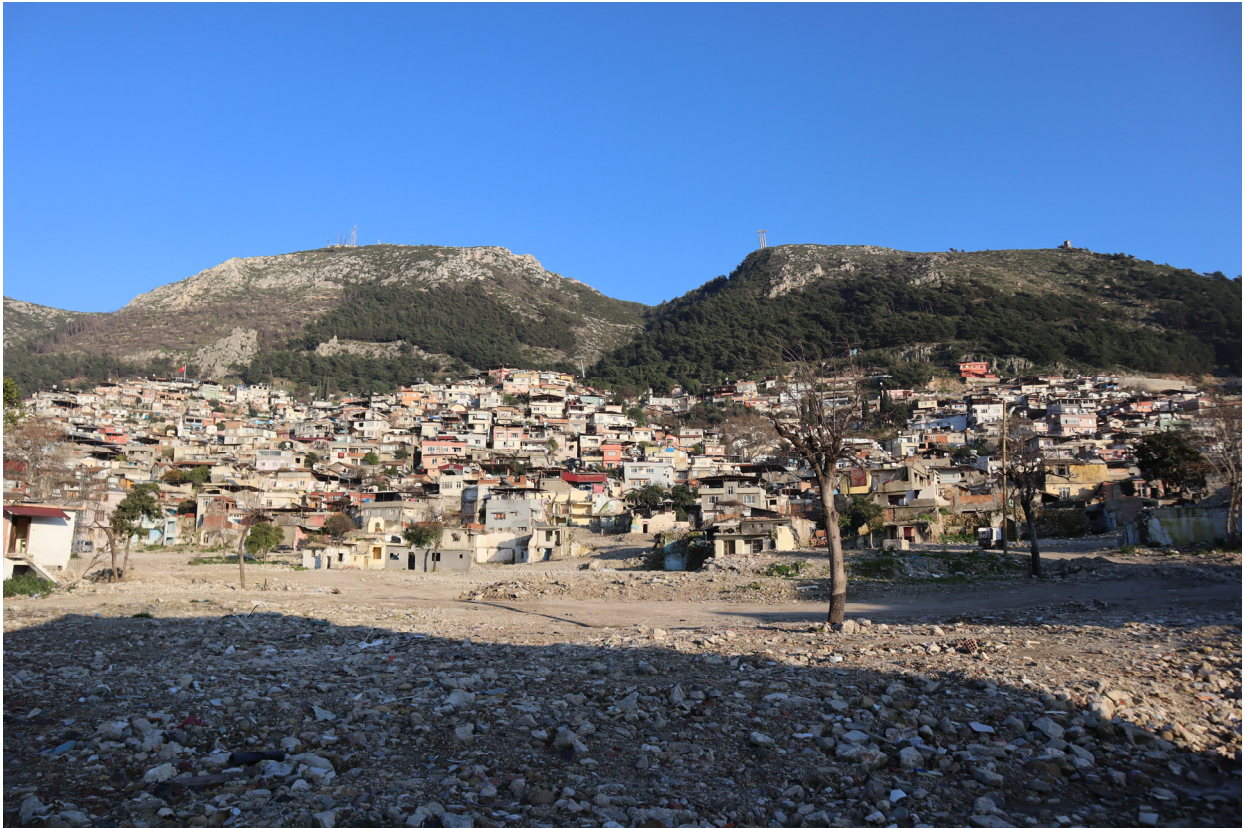
山腹の街は、全く壊れていない。手前は、壊れた建物の瓦礫が撤去された風景が広がる。

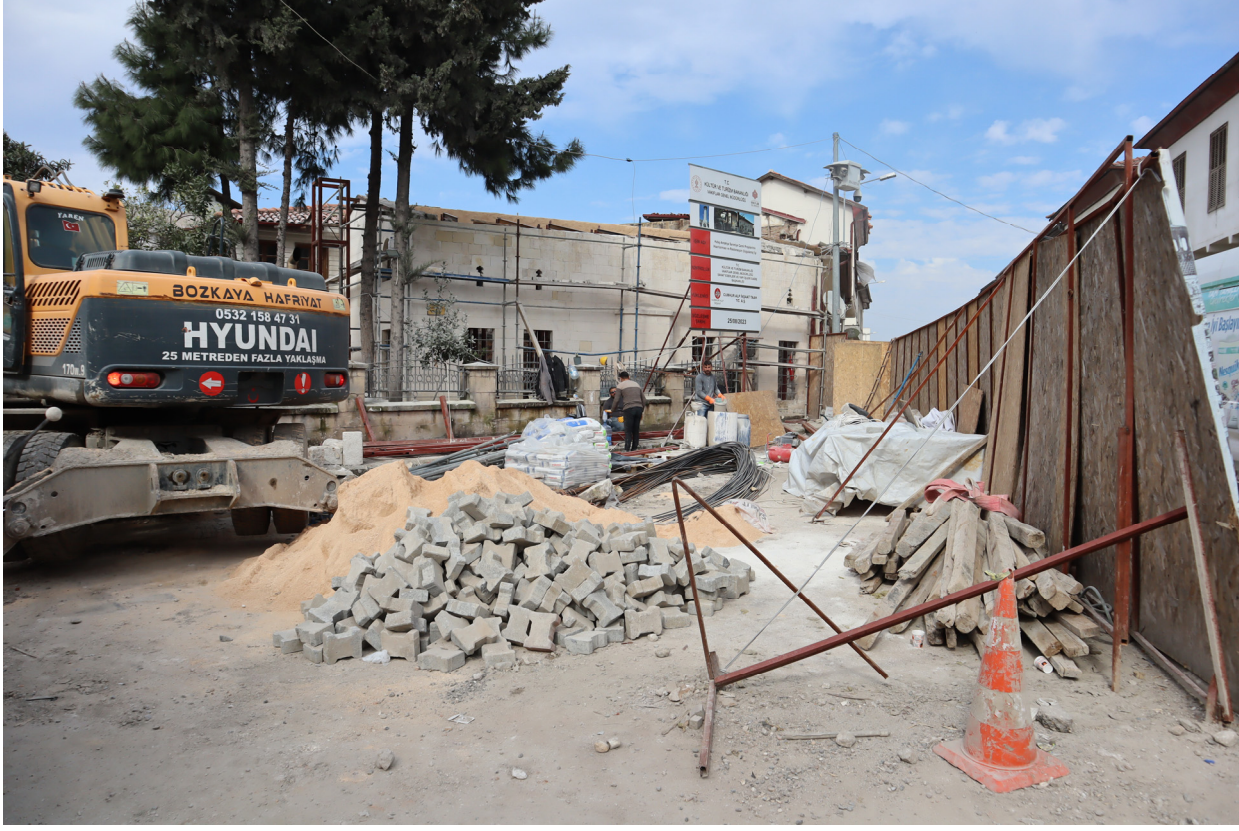
サルミエジャーミイ修復現場。国が仮囲いを施している。ラマダンまでの完成を目指して急ピッチで工事が進められている。

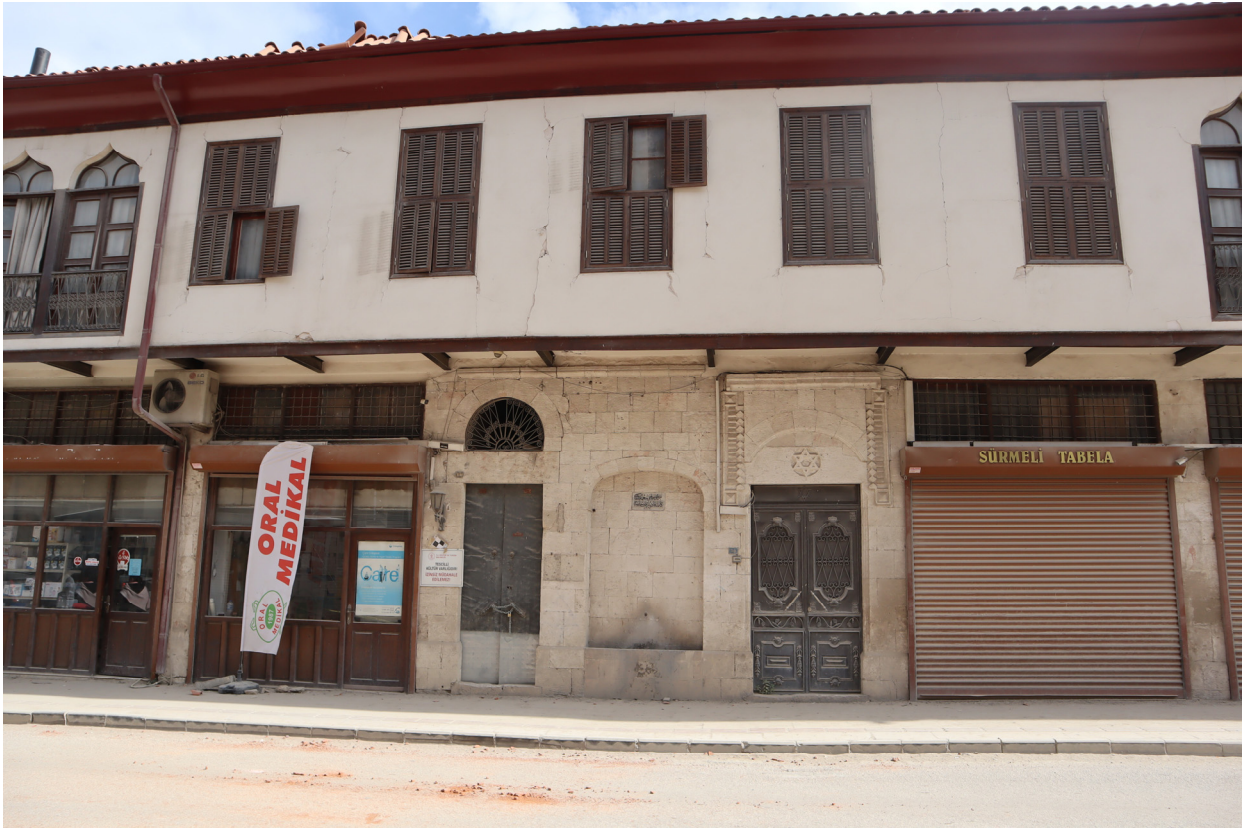
シナゴーク。立ち入り禁止の看板がかかっている。

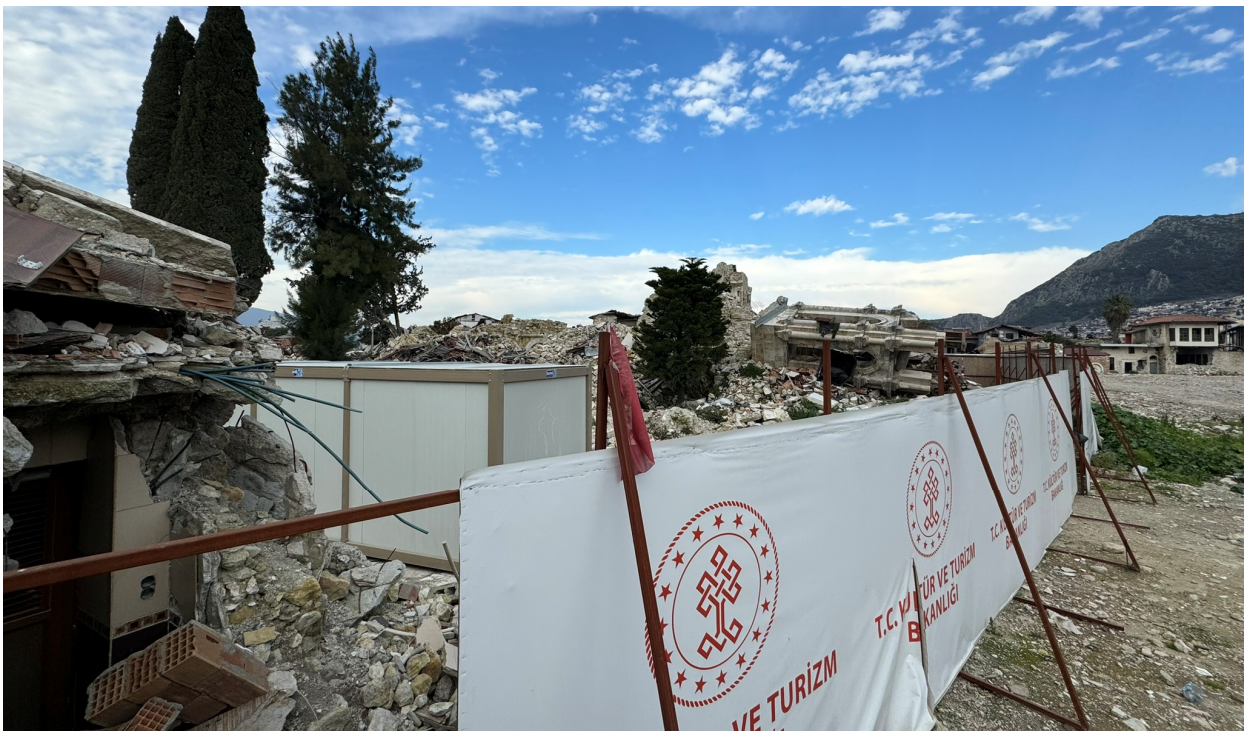
ギリシャ正教会。国によって保護されている。修復は進んでいる気配無し。

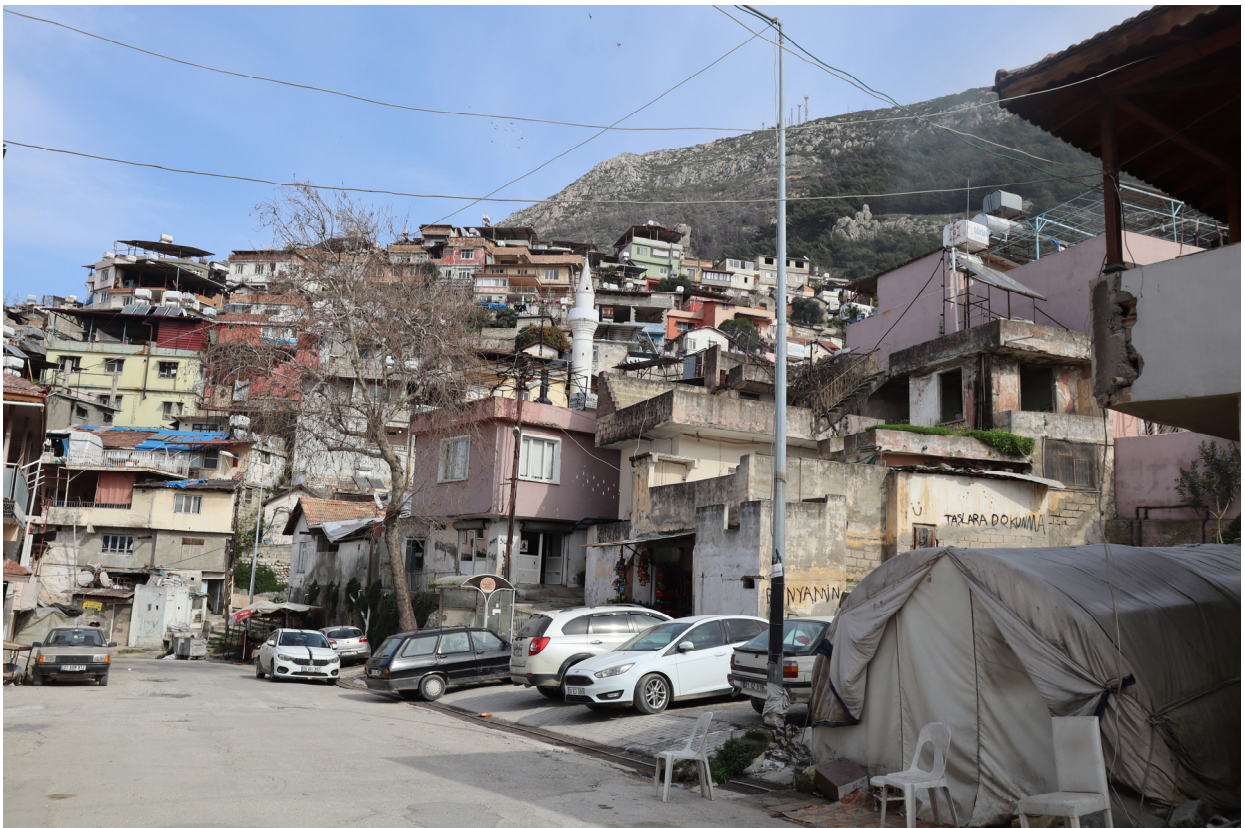
街の様子。地震の影響は見られない。地盤が良いことが要因として考えられる。

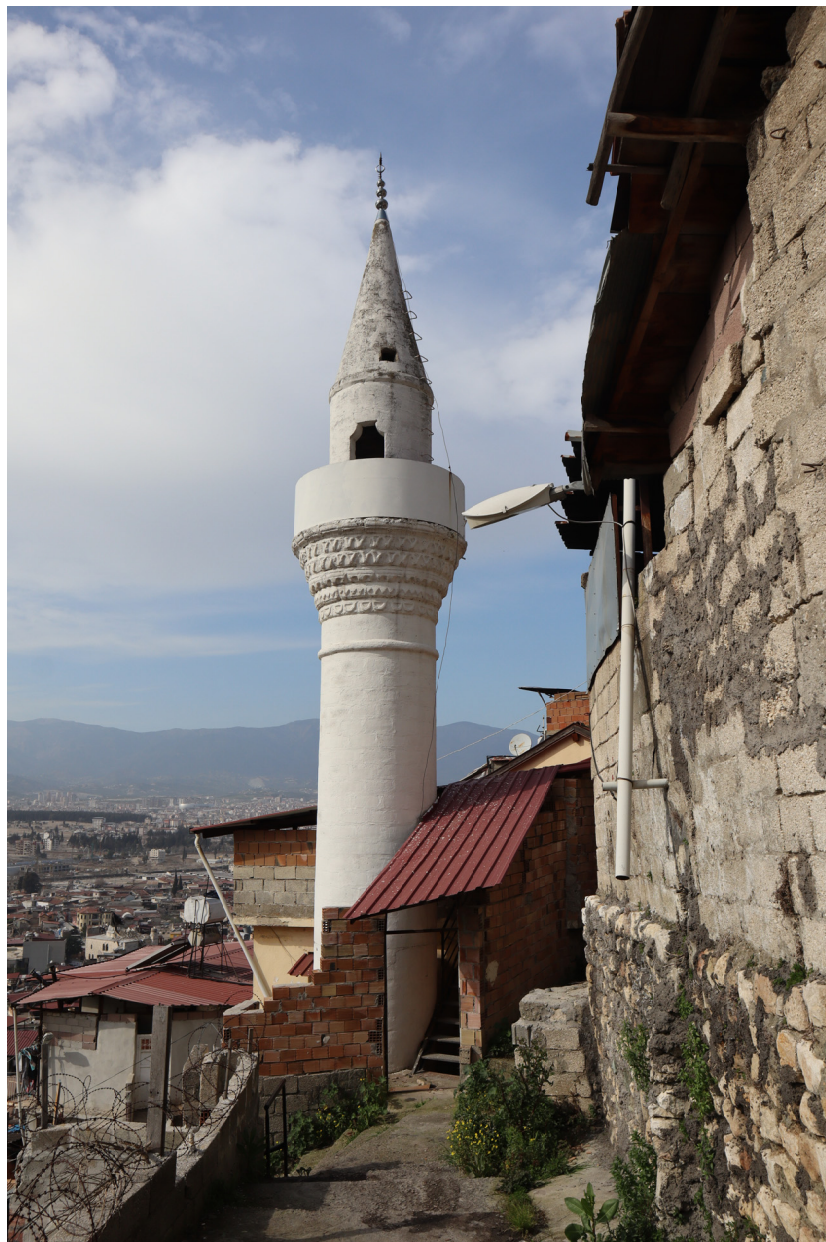
ミナレット。地震の影響を受けていない。

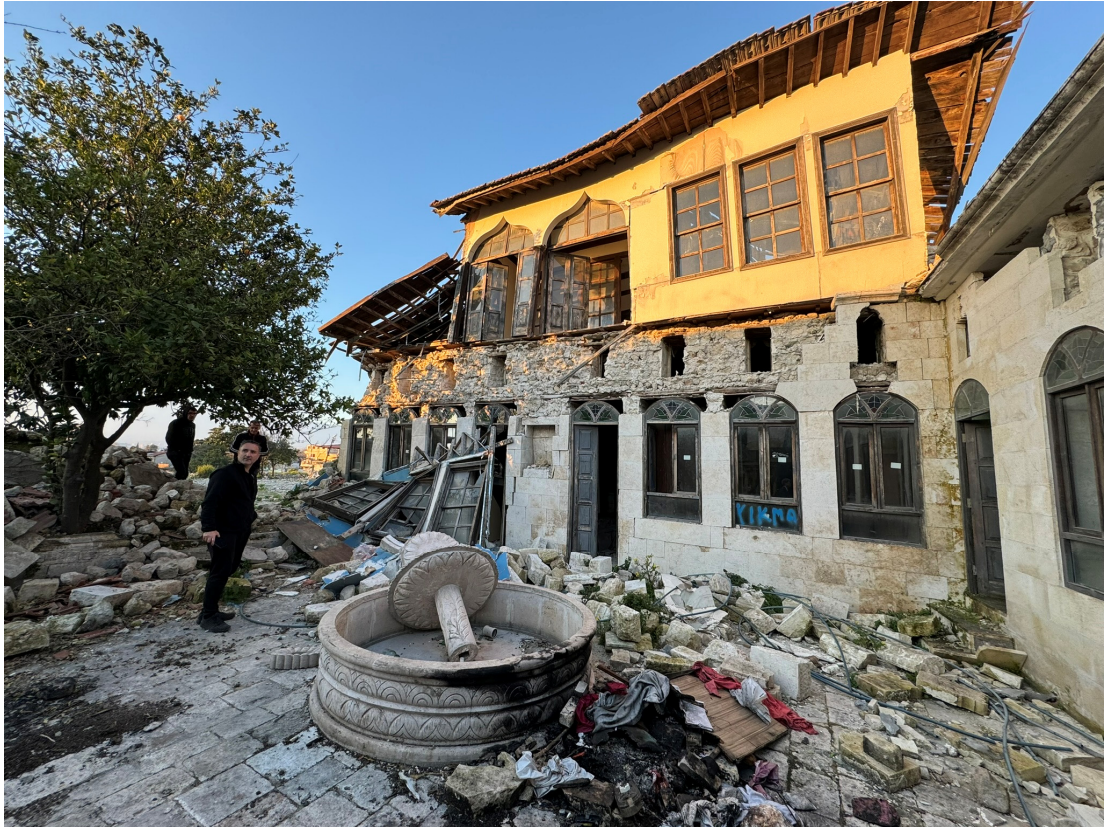
後しっかりと復旧・復興されていくように思われる。一方、住宅等については、仮囲いもなくそのまま放置されていたり、更地になっているところも多い。それらの復旧・復興にあたり、伝統様式がしっかりと尊重されるか、そして伝統様式を踏まえつつ耐震化を進めることができるかが、大きな課題であると思われる。またプロテスタント教会やシナゴグ等の復旧・復興も課題であろう。

崩壊した住宅 そのまま放置されている

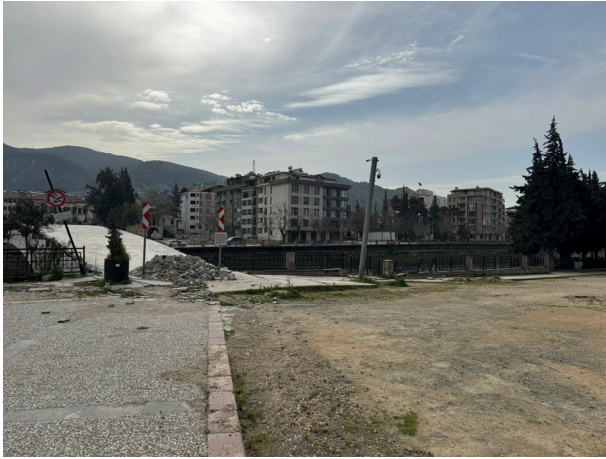
これまで述べてきた「中庭や路地空間」「通りに面する両側町並みの連続性」「川や山がある景観」「ミナレットやドームによるスカイライン」を大切にするためにも、建物のスケールに配慮することは重要である。特にアシ川沿いの建物は、自然景観と調和するためにも、そしてミナレットやドームによるスカイラインを確保するためにも、低層とした方が良い。

アシ川沿いの既存の中層建物

これからのアシ川沿いの建物は低層とした方がよい

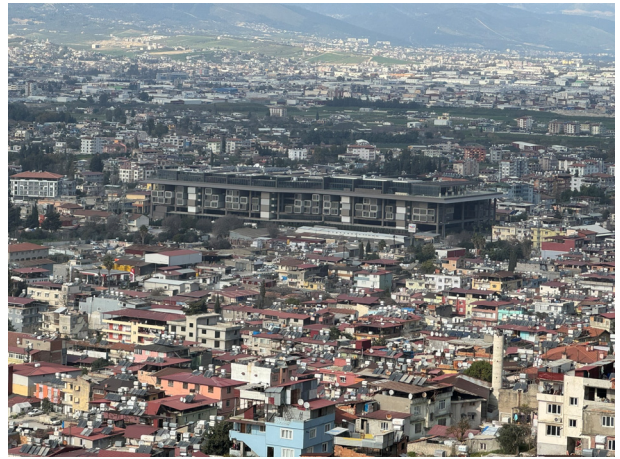
ところで旧市街の北側には、モザイクや浴場などの遺跡の上に、覆い屋のように建てられたホテルがある。そのホテルの大きさはあまりにも大きく、アンタキヤの町並みのスケールを逸脱している。

アンタキヤの町並みのスケールを逸脱したホテル

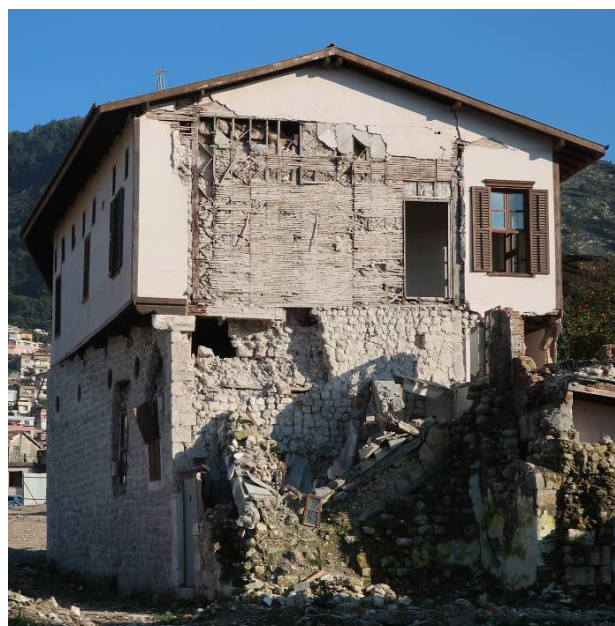
玉石(栗石)組積壁と Bağdadi 外壁

しかし、その他の歴史的建造物あるいは伝統的構法で建てられた建物に対して、震害調査および震害要因分析が行なわれているかは不明である。特に、伝統的構法に依る建物の震害調査および震害要因分析を行なうことを推奨する。

伝統的構法の建物の主な構造は、1層目が無筋の玉石(栗石)組積造で、2層目が瓦葺き Bağdadi 外壁(木軸両面を木摺張りの上漆喰塗りした壁で、木摺間には小石を詰める)の木造軸組である。無筋の玉石(栗石)組積造壁は極めて脆性的であり、微細なひび割れでも耐力低下を生じる。したがって、地震後の残存耐力は、外観からは容易に推定できないと考える。

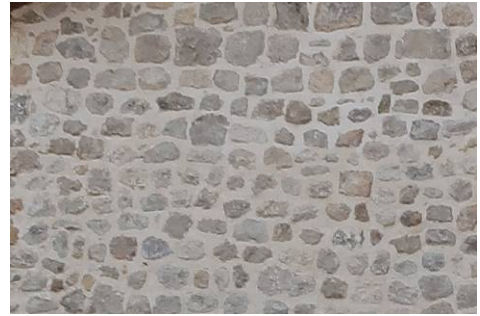
玉石(栗石)組積壁の外観

一方、組積造壁体の基礎構造は不明である。アンタキヤ旧市街地では歴史上数多くの遺跡が地中に埋没し、その上に現在の町並みが建っているものと思われ、地盤および基礎の構造・耐力・耐震性が不確実と推察される。また、中庭形式の住宅では、外壁の一部が塀状に自立した1枚の壁となる部分があり、面外方向の地震力に対して無筋組積造では抵抗し得ない。現に、被災地現場では残存するそのような壁を殆ど目撃していない。何らかの対策が必要と考えるが、そのような部分にあっては、基礎および壁体に鉄筋コンクリート構造を用いることも致し方ないものとする。

また、組積造壁の天端には木造床組・床板が載っているが、組積造壁の水平剛性に比して、木造床の面内水平剛性は低いと推察される。木造床を無視しても組積造壁が地震水平力に耐えるならば問題ないが、木造床を介して再配分する必要があるならば、十分な面内水平剛性を有する床面が必要となる。床剛性が不足すれば、地震力が再配分される以前に、自立できない組積造壁に損傷を生じ得る。

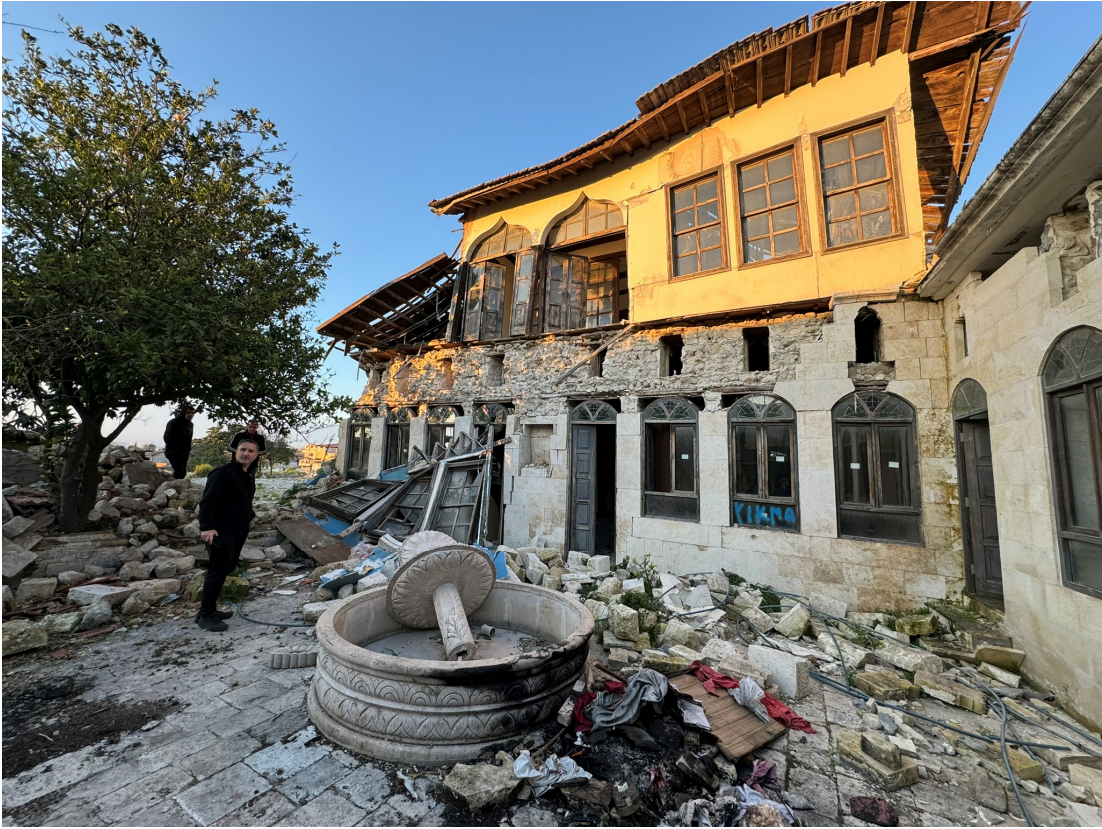
Destroyed residential building Left neglected

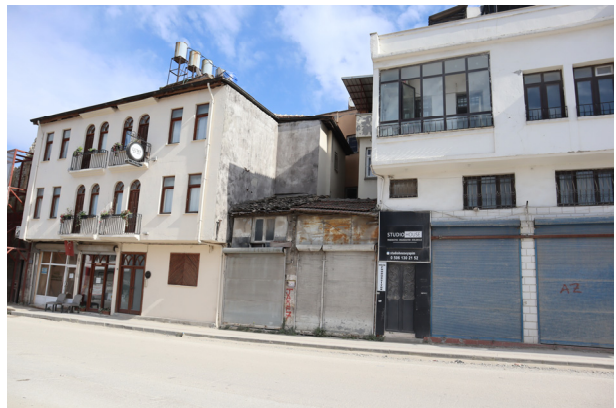
On the other hand, the buildings on the right are taller and are not aligned with the townscape on the left

Kurtuluş Street The continuity of the townscape is broken

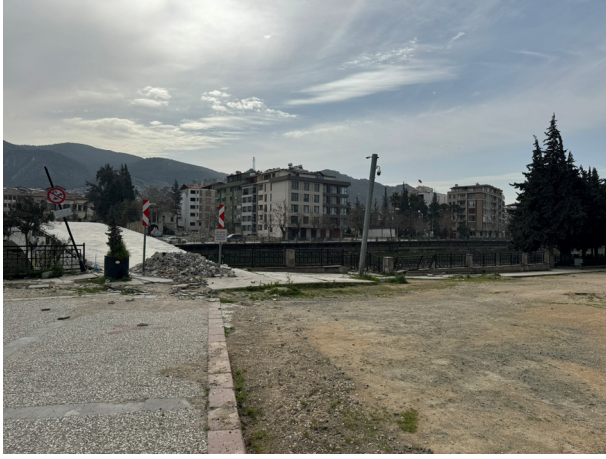
Existing mid-rise buildings along the Asi River  
Further buildings along the Asi River should be low-rise

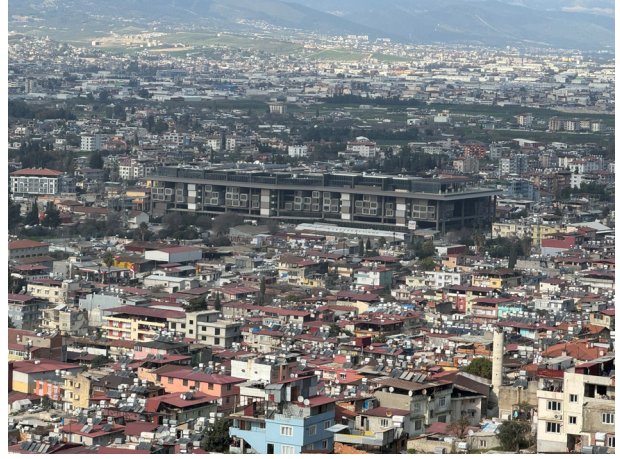
By the way, on the north side of the old city, there is a hotel built like a covered house over the ruins of mosaics and baths. The size of that hotel is so large that it deviates from the scale of Antakya's townscape.

Hotel deviating from the scale of the Antakya townscape

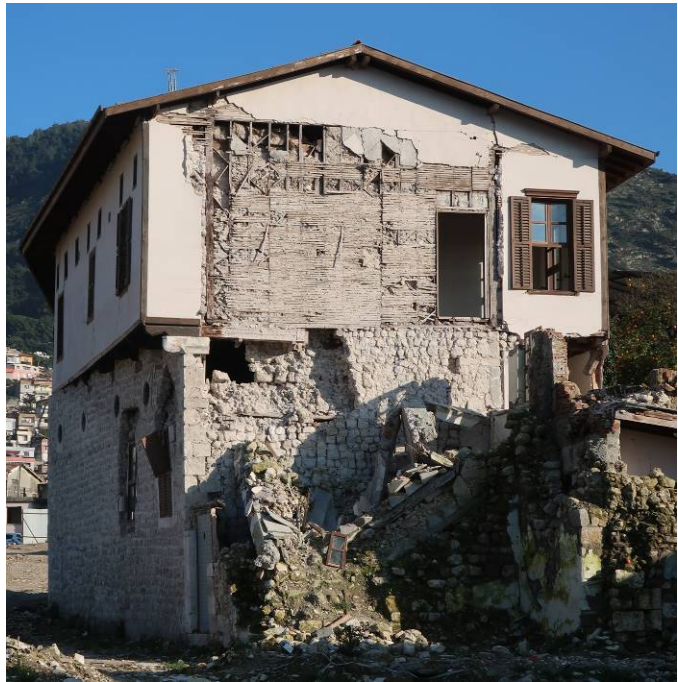
Wall of rubble stone masonry and Bağdadi wall

However, it is unclear whether earthquake damage surveys and earthquake damage factor analysis have been conducted on other historical buildings or buildings built using traditional construction methods. In particular, we recommend earthquake damage surveys and earthquake damage factor analysis of

The main structure of buildings using traditional construction methods has a first layer of unreinforced rubble stone masonry and a second layer that is a wooden frame with roof tiles and Bağdadi exterior walls (walls with wooden frames covered with wood laths on both sides and plastered, filled with pebbles between the sidings). Unreinforced rubble stone masonry walls are extremely brittle, and even minute cracks can cause a decrease in strength. Therefore, we believe that the residual strength after an earthquake cannot be easily estimated from appearance.

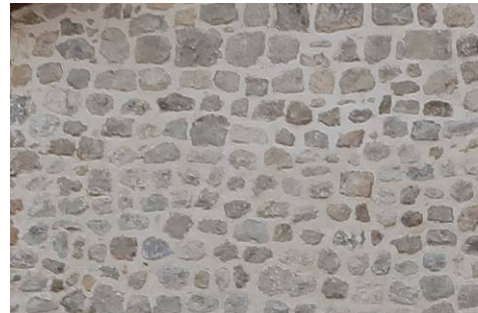
Exterior view of rubble stone masonry wall

Conversely, the substructure of the masonry walls is unknown. In the old city of Antakya, many historic ruins have been buried underground, and the current townscape is believed to have been built on top of them. The structure, strength, and earthquake resistance of the ground and foundations are presumably uncertain. In addition, in courtyard-style houses, some of the exterior walls have sections that are self-standing single walls, like a fence, and unreinforced masonry cannot resist earthquake forces in out-of-plane directions. In fact,

Poor mortar

hardly any remaining walls can be found in disaster-stricken areas. We believe that some kind of countermeasures are necessary and that in such sections, using reinforced concrete structures for the foundations and walls is unavoidable.

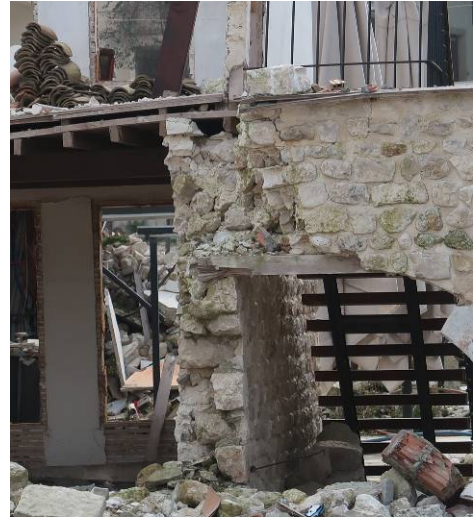
Rubble stone masonry and wooden floor

In addition, although a wooden floor assembly and floorboards rest on top of the masonry walls, the in-plane horizontal rigidity of the wooden floor is presumed to be lower than the horizontal rigidity of masonry walls. If the masonry walls can withstand seismic horizontal forces, ignoring the wooden floor does not create any issues. However, if redistribution through the wooden floor is necessary, then a floor framing with sufficient in-plane horizontal stiffness is required. Lack of floor stiffness can cause damage to non-self-supporting masonry walls before seismic forces can be redistributed.
