Environmental Factors and Material Characteristics Influencing the Deterioration of the Nikka Stone in the Former Koshien Hotel

Tomoko Uno¹, Chisato Isoi¹, Chiemi Iba² and Koki Yamada²

¹ Department of Architecture, Mukogawa Women's, University, Nishinomiya, Japan

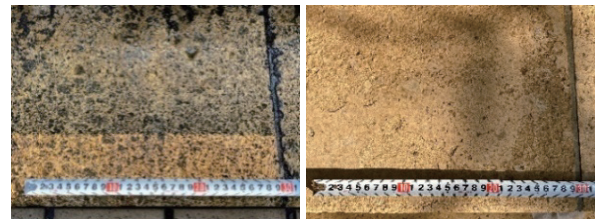
It is evident from Figure 1 that the Nikka stone is more porous than the Tatsuyama stone. The holes in the Nikka stone are a few millimeters wide, whereas the Tatsuyama stone is quite dense. The dry density of Nikka stones, which contain many

Figure 1 Outer appearance of the Nikka stone (left) and the Tatsuyama stone (right)
