# Survey Report on the Areas Affected by the Earthquake with Epicenter in Southeastern Turkey

School of Architecture, Mukogawa Women's University, Japan

August 2023

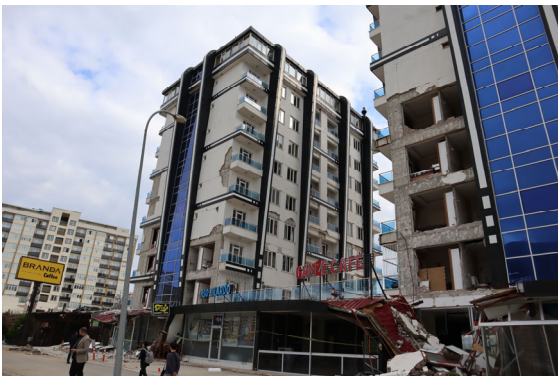
Photo 1-4 Onikişubat, K.Maraş.  
Peeling of exterior walls of apartment buildings.

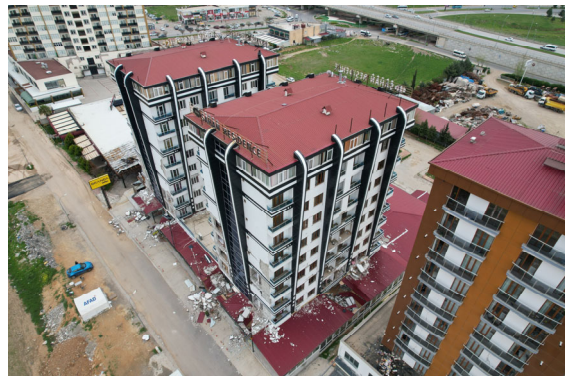
Photo 1-5 Onikişubat, K.Maraş.  
Drone shot of apartment buildings in Photo 1-4.

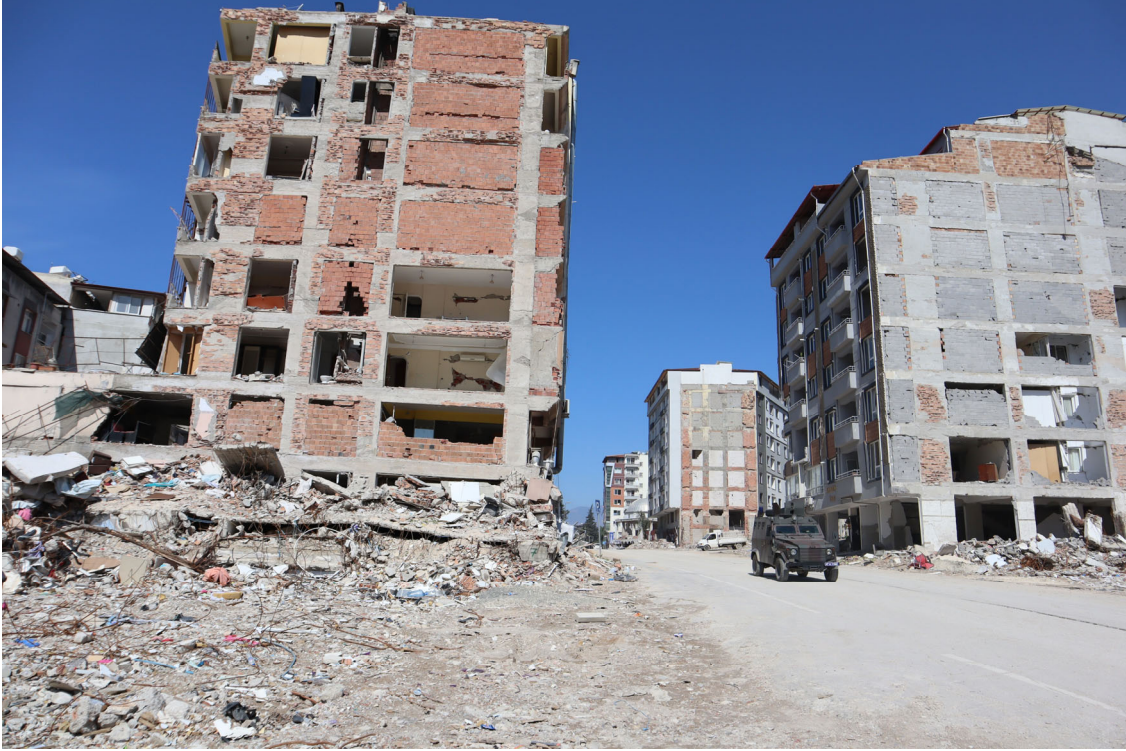
Photo 1-16 Antakya, Hatay. The town was devastated and the military was in charge of the town. Only locals were allowed to enter, and we were given special permission to inspect the site. The famous Hatay Archaeology Museum was sealed off and could not be seen.

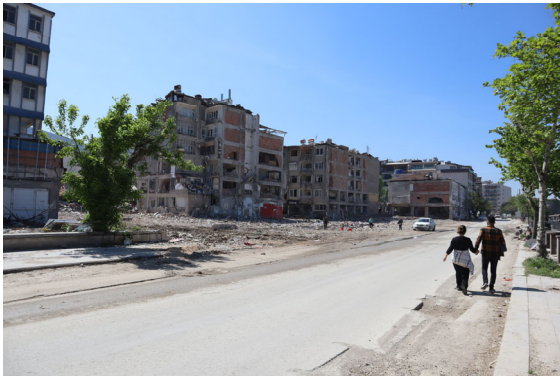
Photo 1-26 Antakya, Hatay.  
The seven-story townscape was gone.

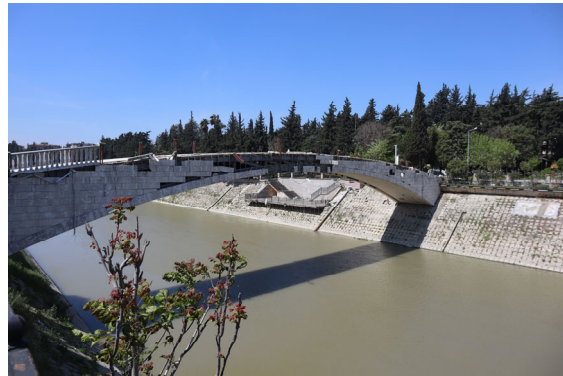
Photo 1-27 Antakya, Hatay.  
Peeling of bridge finishing materials.

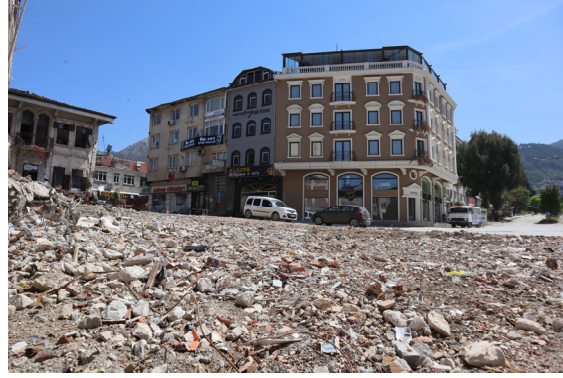
Photo 1-40 Antakya, Hatay.  
There was also an intact hotel.

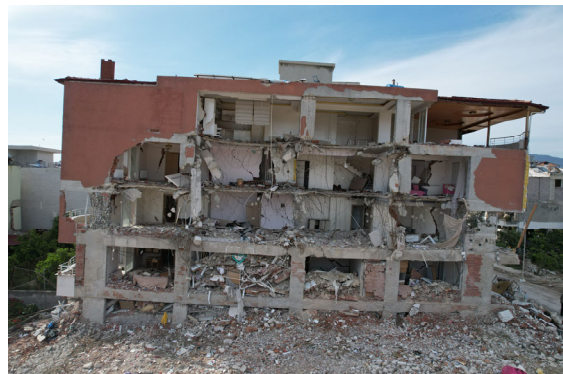
Photo 1-51 Samandağ, Hatay.  
This was originally a six-story apartment building.  
The first and second floors were crumbling.

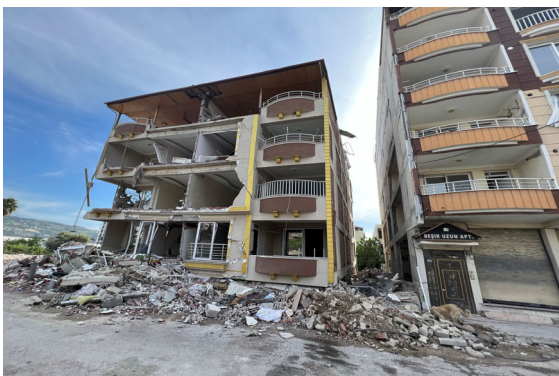
Photo 1-52 Samandağ, Hatay. Photo from another angle.  
Originally bordered by the neighboring building.

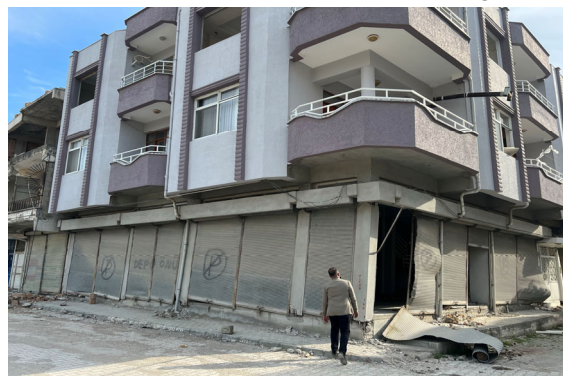
Photo 1-53 Samandağ, Hatay.  
A building whose layers were collapsing.

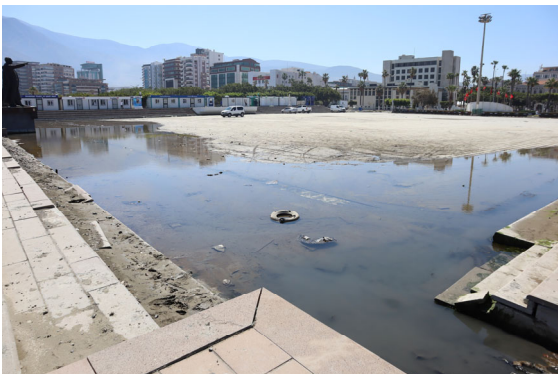
Photo 1-55 İskenderun, Hatay. Liquefaction.

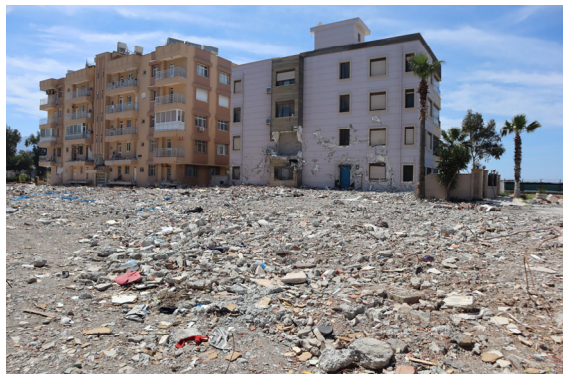
Photo 1-63 İskenderun, Hatay.  
A 7-story apartment building collapsed. The columns of the restaurant on the first floor had been removed by the owner.

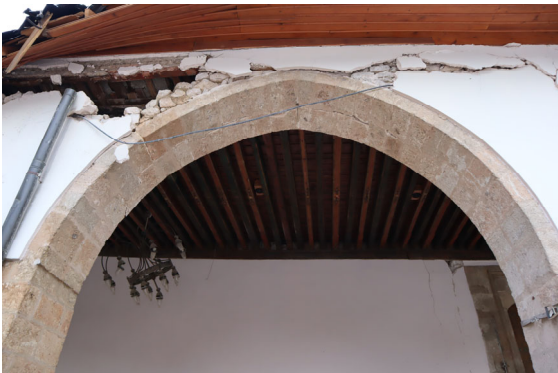
Photo 5-5 Arch section of portico

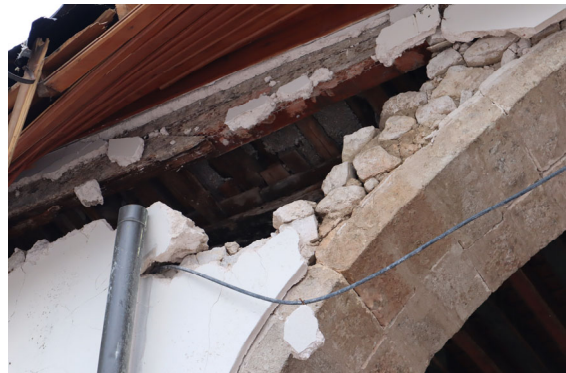
Photo5-6 Arch section of portico

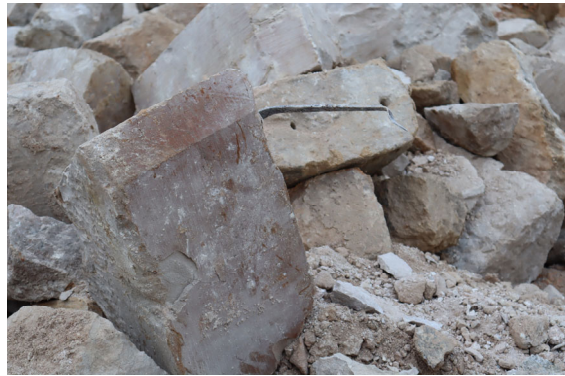
Photo 5-9 Steel tie connecting the stones of the collapsed minaret.

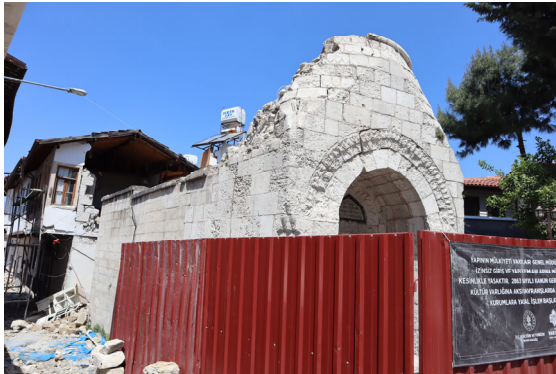
Photo 5-20 Antakya, Hatay.  
Protestant Church.

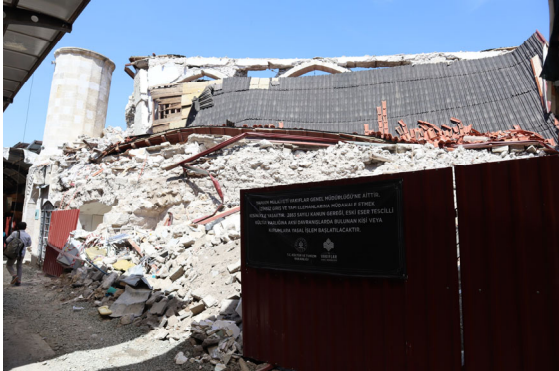
Photo 5-22 Antakya, Hatay. Habib-i Neccar Camii  
The minaret and dome collapsed.

In all of the traditional mosques that we were able to inspect, the minarets had collapsed. In addition, in the Kahramanmaraş Ulu Camii, it was confirmed that the building was damaged due to collapsed minarets. The development of seismic reinforcement methods for masonry structures is urgently needed to protect cultural heritage buildings, and among them, the promotion of seismic reinforcement of minarets is expected to have a very immediate effect in protecting cultural heritage buildings.
