「トルコ共和国における歴史的市街地の復興に関する国際貢献事業」

# 報告書

武庫川女子大学

2024年3月

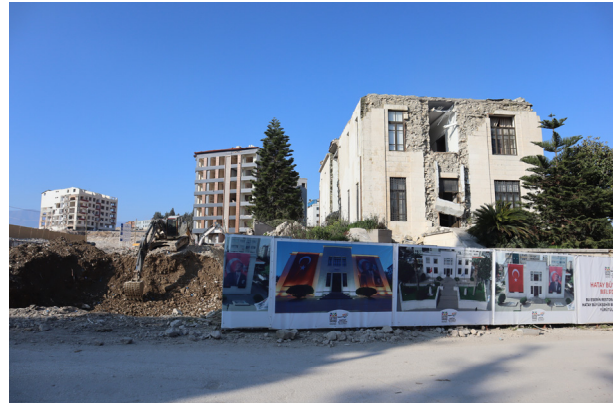
ハタイ大都市自治体市庁舎の修復現場。同自治体が修復を主導。

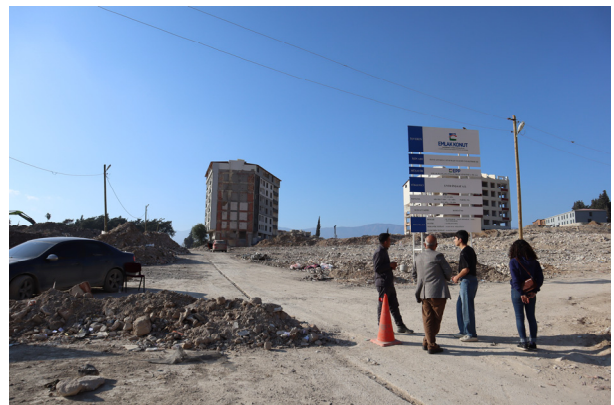
新市街の様子。地盤改良工事が進む。

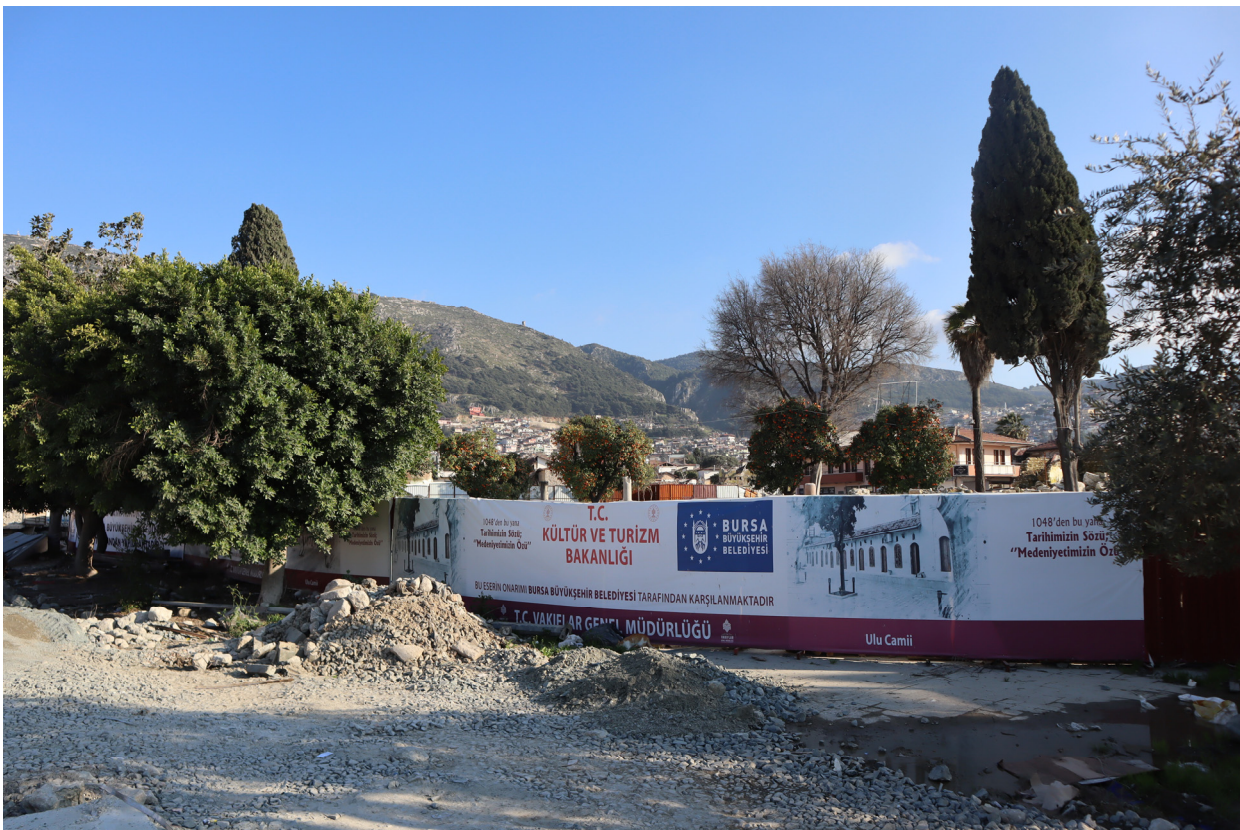
ウルジャーミィ修復現場。国が仮囲いを施している。ブルサ大都市自治体が修復を支援している。

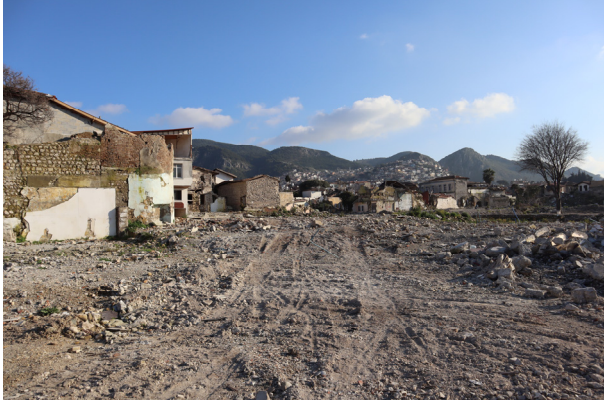
旧市街。瓦礫が整理された風景が広がる。

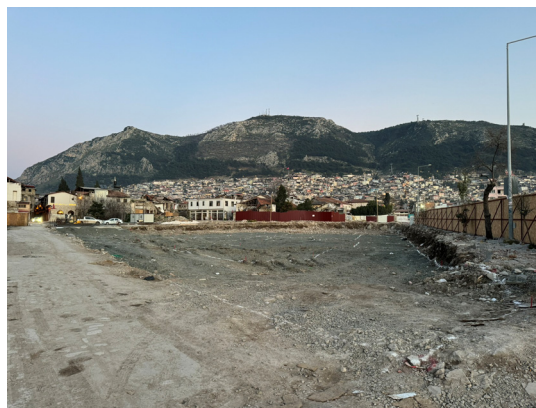
ウズンチャルシュの倒壊現場。これから工事が始まろうとしている。

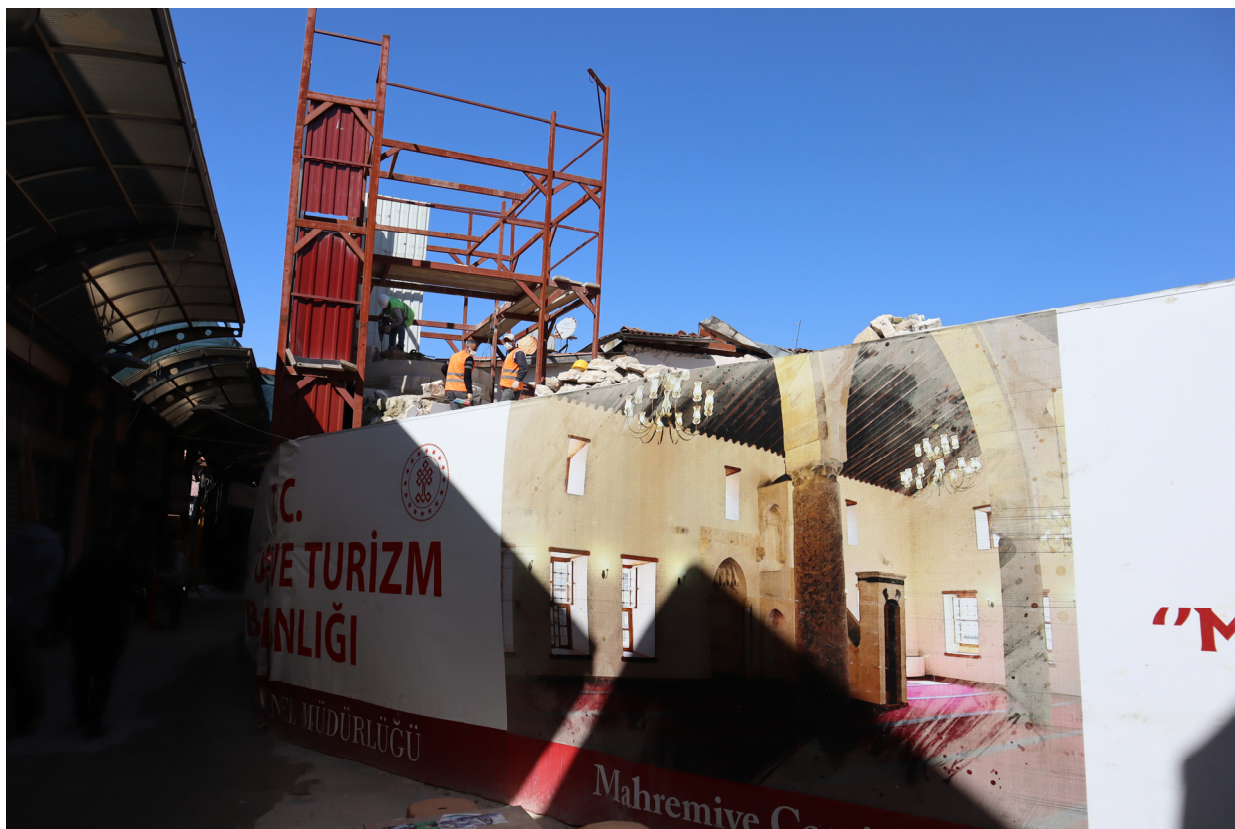
マフレミエジャーミイ修復現場。ミナレットを解体しているところ。

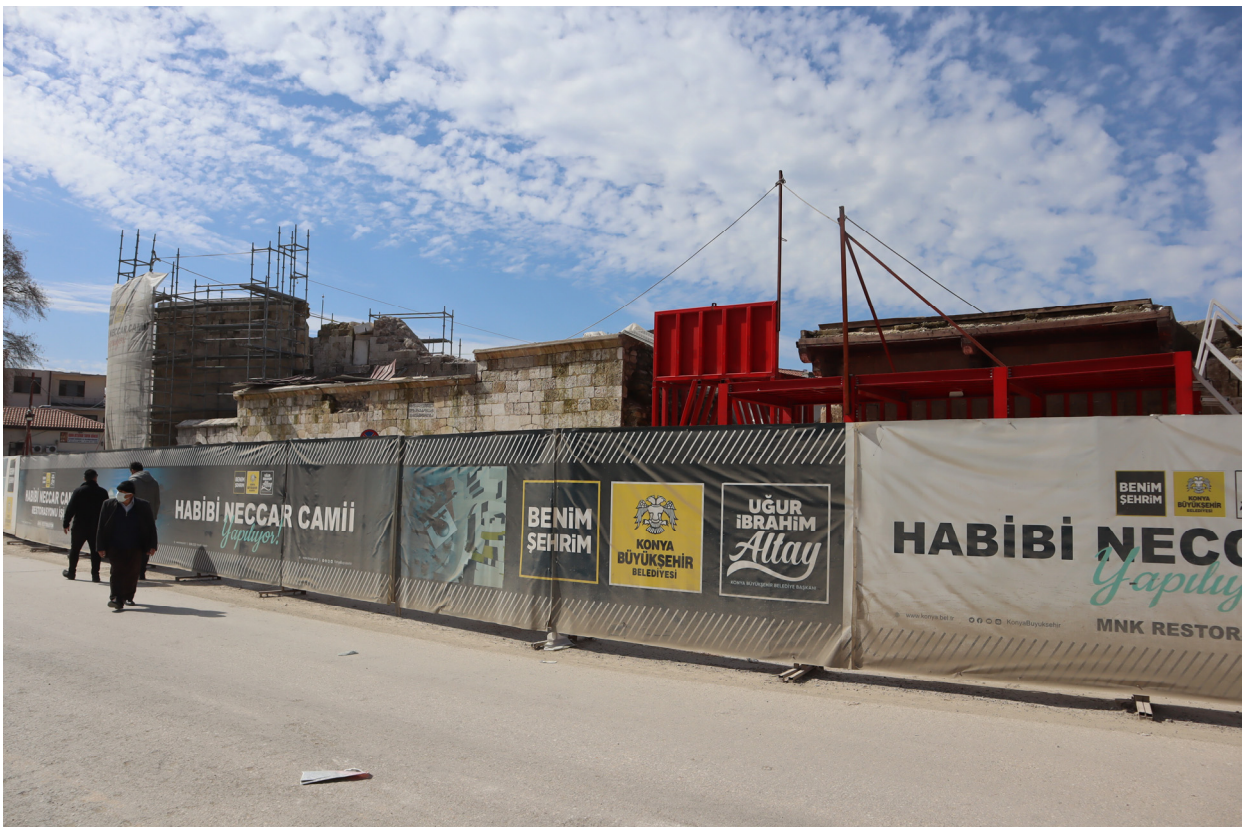
ハビビネッジャールジャーミイ修復現場。国が仮囲いを施している。コンヤ大都市自治体が修復を支援している。

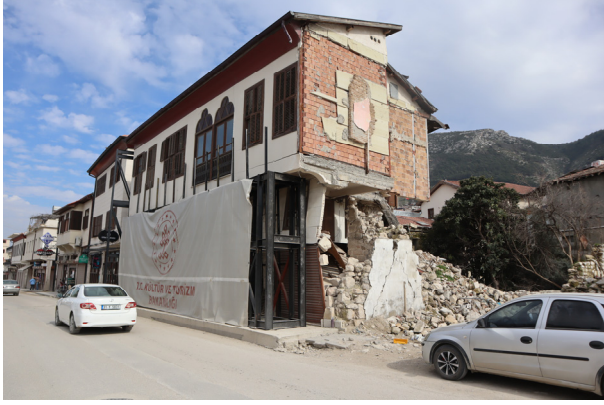
クルトゥルシュ通りの文化財建造物。  
倒壊しないように鉄骨で支えている。

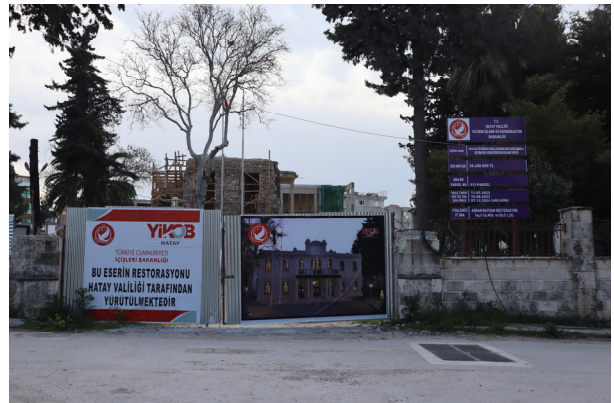
プロテスタント教会。壊れたまま残されている。

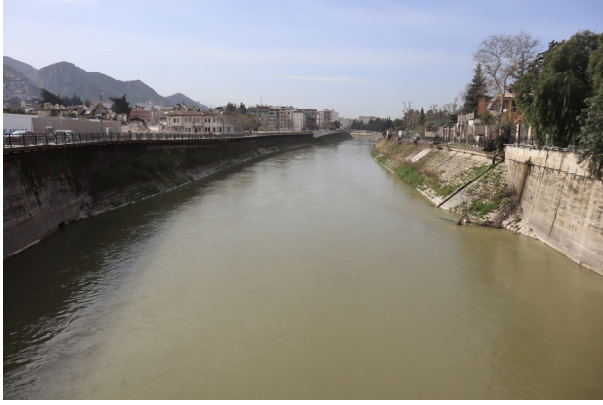
アシ川。現状は人が水に近づくことができず親水性に乏しい。

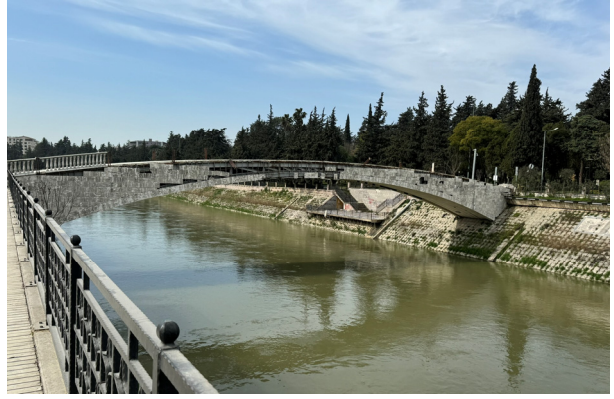
地震で欄干が壊れた橋。現在も人が橋を渡っている。

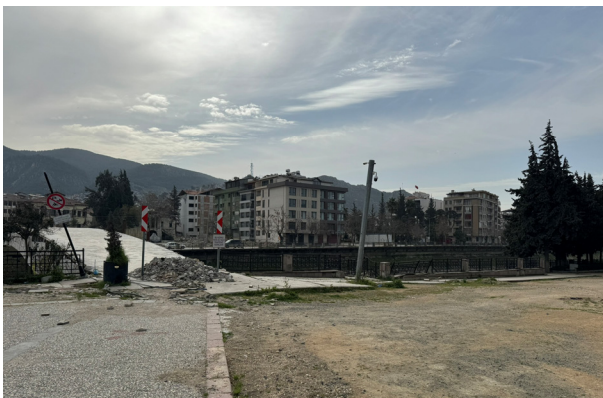
アシ川沿いの既存建物。高さが山の景観を阻害している。

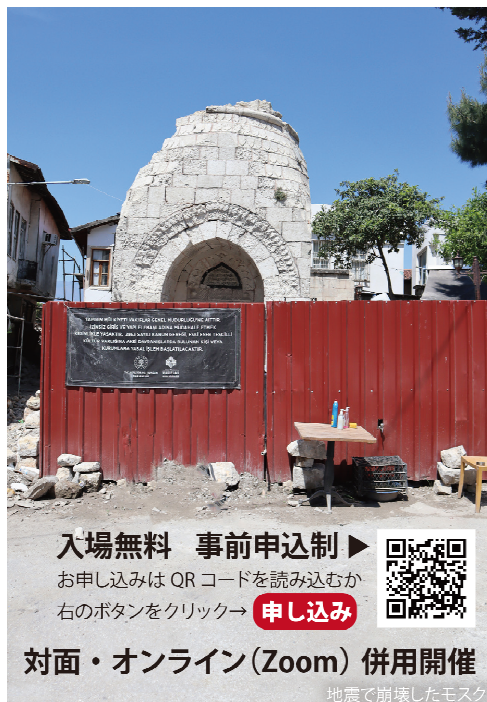
地震で崩壊したモスク

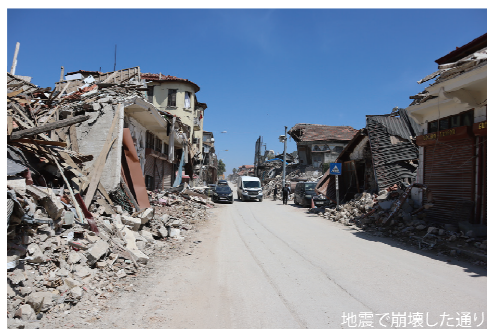
地震で崩壊した通り

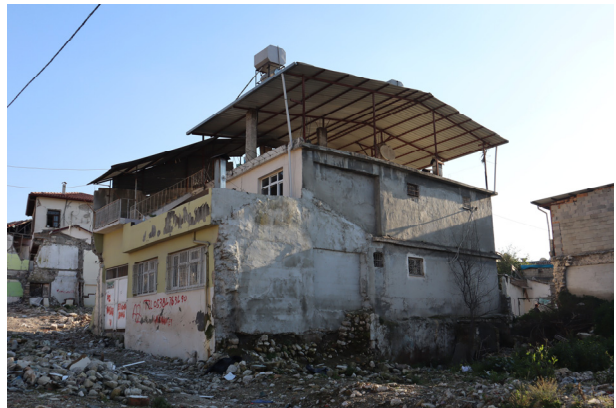
RC造の建物 小屋組は鉄骨 景観にそぐわない

例えばジャーミィ（＝モスク）では、外壁は切石積み、屋根はアラトゥルカと呼ばれる赤瓦がよく使われている。住宅等の建物では、1階は石造で切石積みや丸石積み等、2階は木造でバーダーディと呼ばれる構法が用いられ、そして屋根はアラトゥルカや、マルシリアと呼ばれる赤瓦（＝マルセイユ瓦）が使われる。フランス委任統治時代の建物も石造である。これから建物を復旧・復興するにあたり、石、木、瓦といった伝統的な材料を大切にし、鉄筋コンクリートや鉄骨の安易な利用は避けたいところである（もちろんしっかりと検討されているならば、それらの利用を拒むものではない）。

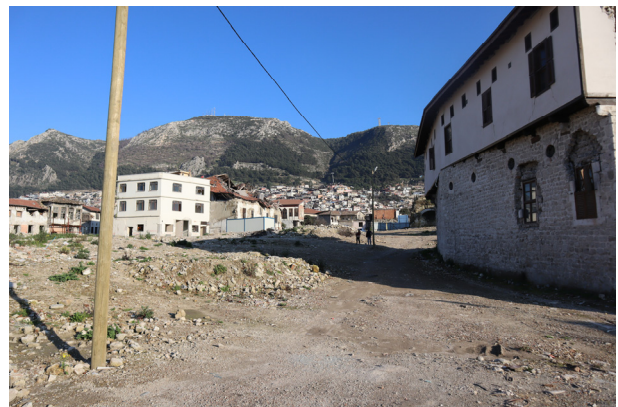
Alleys used to be maze-like but are now landscapes like this, with the rubble cleared away

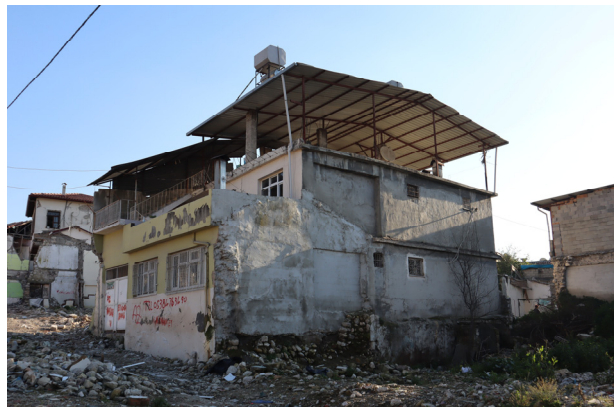
Reinforced concrete (RC) building Steel roof frame  
Does not suit the scenery

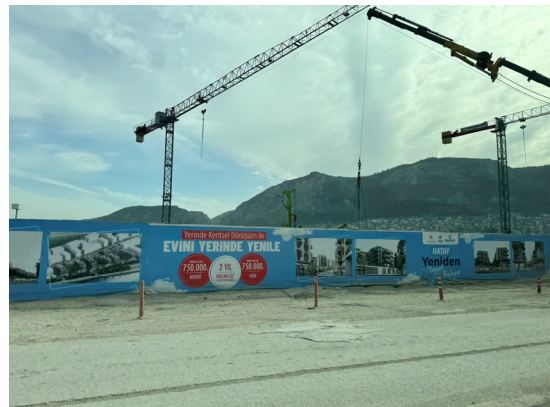
Apartment construction site along the river in the new city

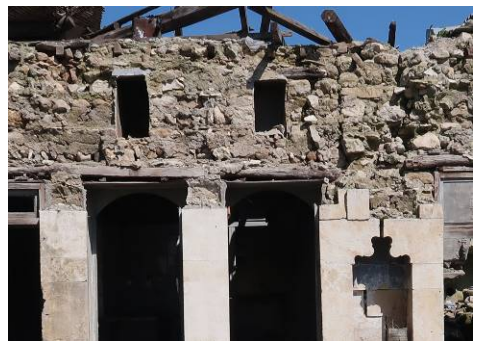
Rubble stone masonry and ashlar cladding

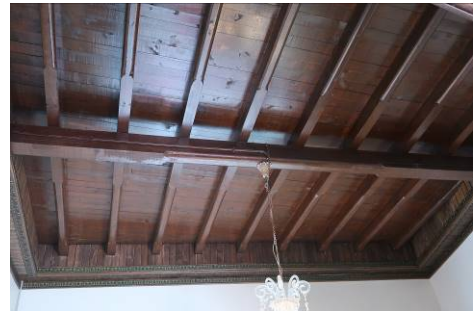
In addition, although a wooden floor assembly and floorboards rest on top of the masonry walls, the in-plane horizontal rigidity of the wooden floor is presumed to be lower than the horizontal rigidity of masonry walls. If the masonry walls can withstand seismic horizontal forces, ignoring the wooden floor does not create any issues. However, if redistribution through the wooden floor is necessary, then a floor framing with sufficient in-plane horizontal stiffness is required. Lack of floor stiffness can cause damage to non-self-supporting masonry walls before seismic forces can be redistributed.

Wooden floor framing
