# Survey Report on the Areas Affected by the Earthquake with Epicenter in Southeastern Turkey

School of Architecture, Mukogawa Women's University, Japan

August 2023

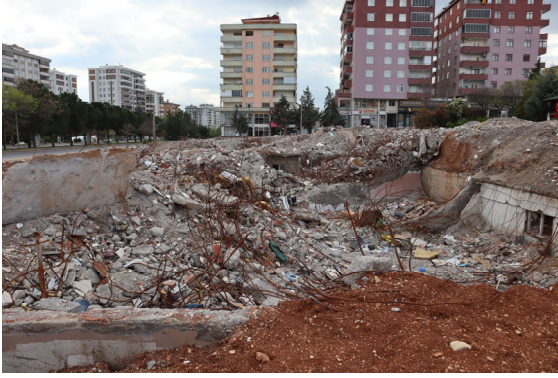
Photo 1-6 Onikişubat, K.Maraş.

Three 10-story buildings were destroyed.  
Debris has already been removed in many places.

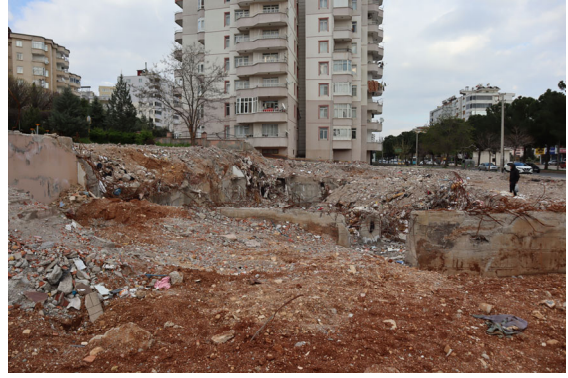
Photo 1- 7 Onikişubat, K.Maraş.

Opposite side of photo 1-6. People were living in the apartment building in the back.

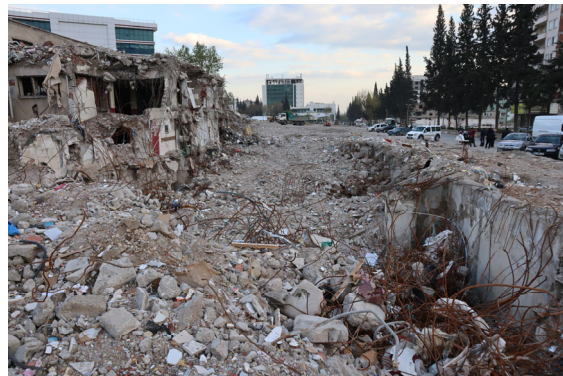
Photo 1-13 Dulkadiroğlu, K.Maraş. The government building

can be seen in the back. Buildings were lost in large areas.

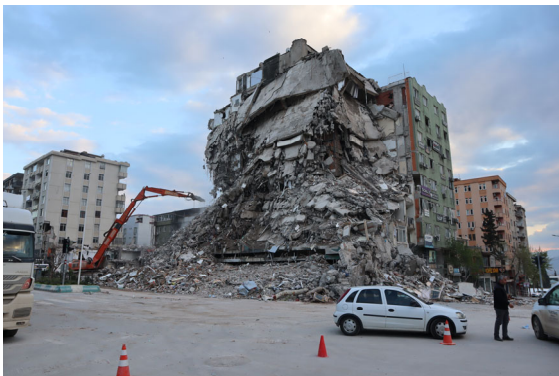
Photo 1-14 Dulkadiroğlu, K.Maraş.

Building demolition site.

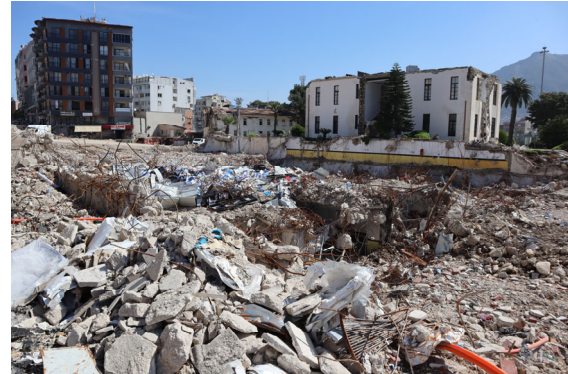
Photo 1-18 Antakya, Hatay.  
Ruins of Hatay Metropolitan Municipality Office Building.

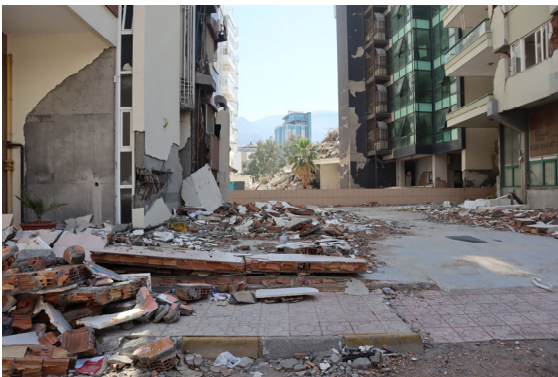
Photo 1-57 İskenderun, Hatay.

Peeling of exterior walls of apartment buildings.

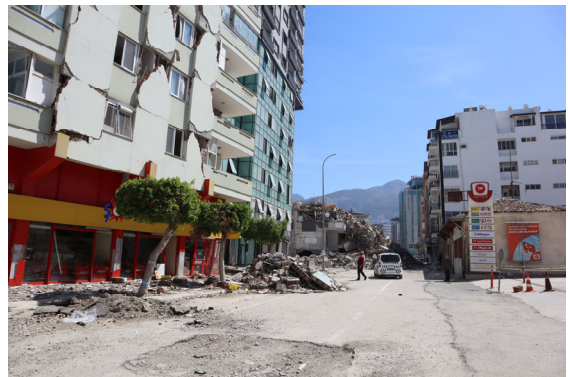
Photo 1-58 İskenderun, Hatay.

In the back, a 12-story apartment building collapsed.

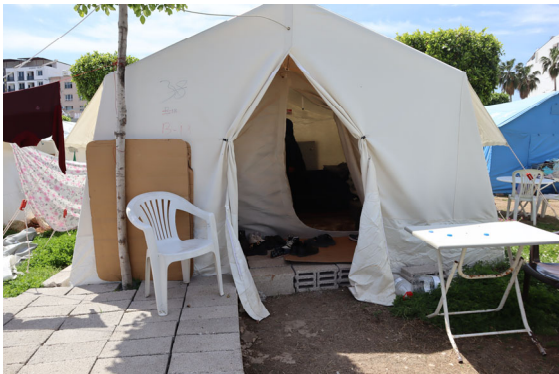
Photo 4-11 Residential tent. Heat was becoming a problem.

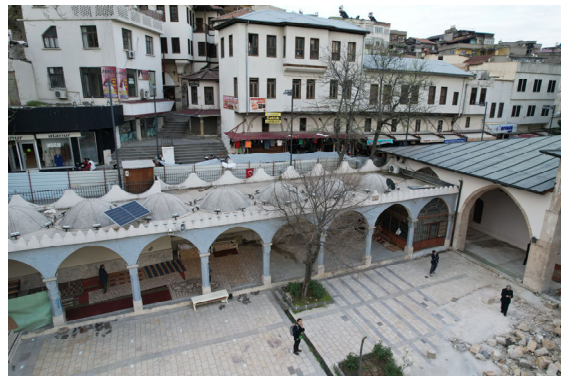
Photo 5-14 The surrounding corridor was safe.

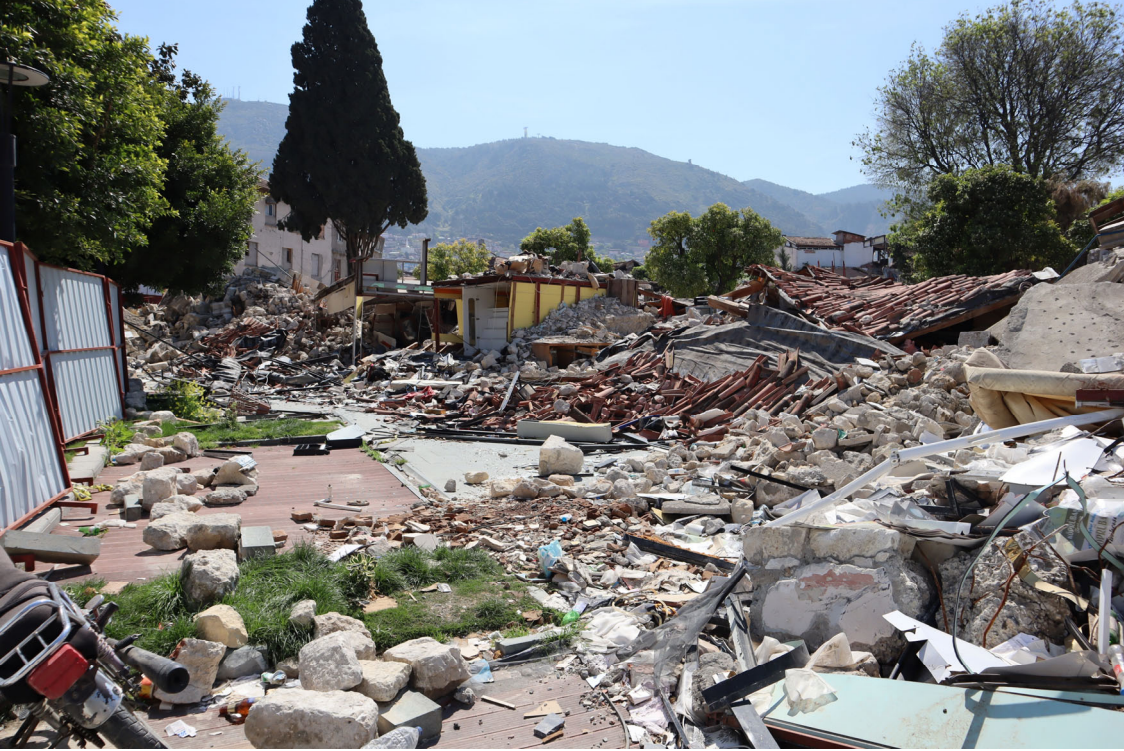
Photo 5-17 Antakya, Hatay. Ulu Cami.

The famous minaret was erected near the tree in front, but it was completely destroyed along with the building.

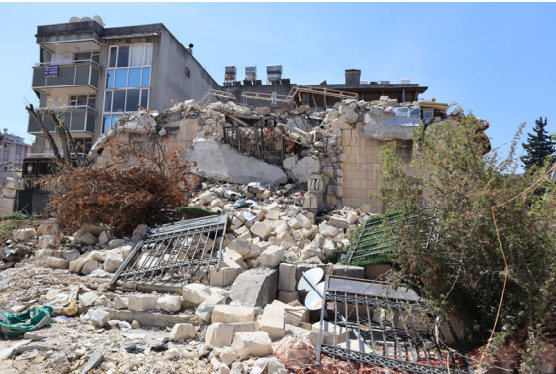
Photo 5-19 Antakya, Hatay. Greek Orthodox Church.
