「トルコ共和国における歴史的市街地の復興に関する国際貢献事業」

# 報告書

武庫川女子大学

2024年3月

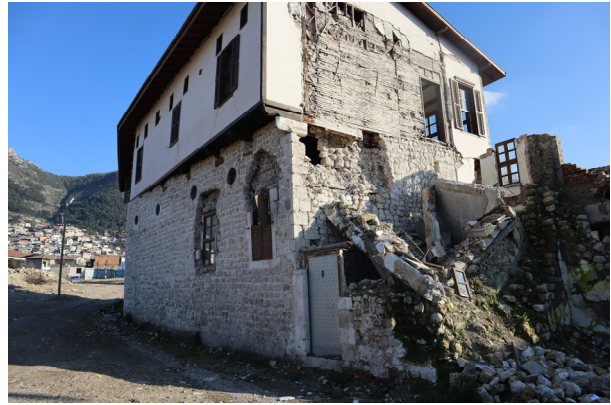
ジュンバと呼ばれる、2階が張り出す伝統的な形態。  
1階は石造。2階は木造。木造の手前側壁面はパーダーディ。

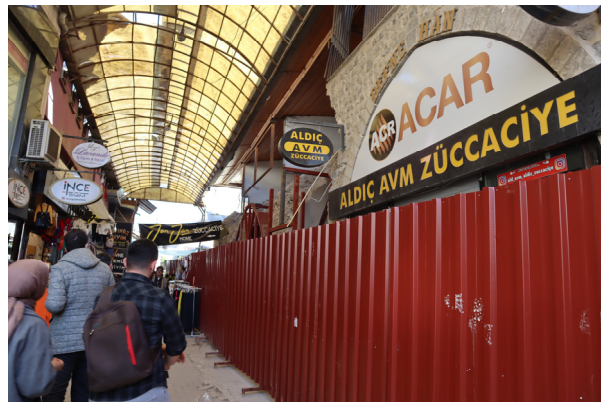
ウズンチャルシュ。囲いでハンを保護している。

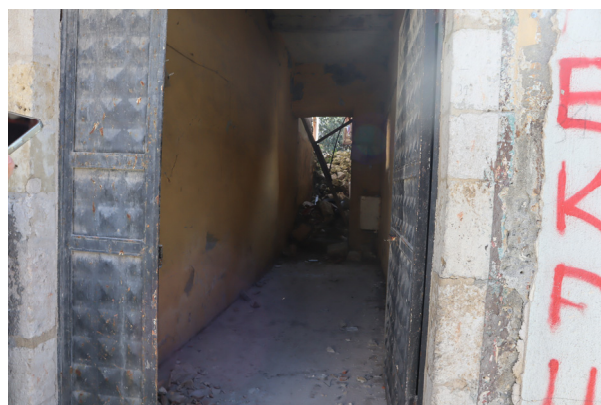
ドアをあけると瓦礫が見えた。

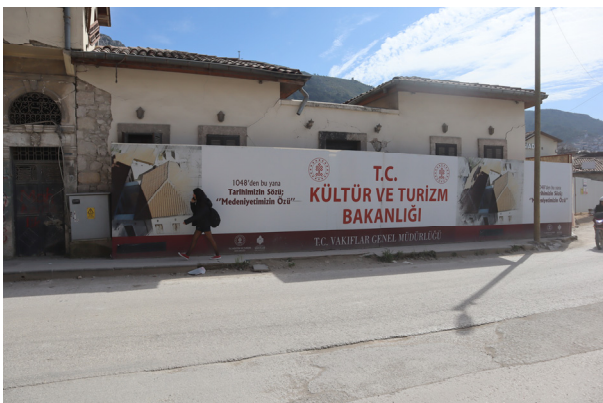
クルトウルシュ通りの文化財建造物。国が保護している。

Kurtuluş Street The continuity of the townscape is broken

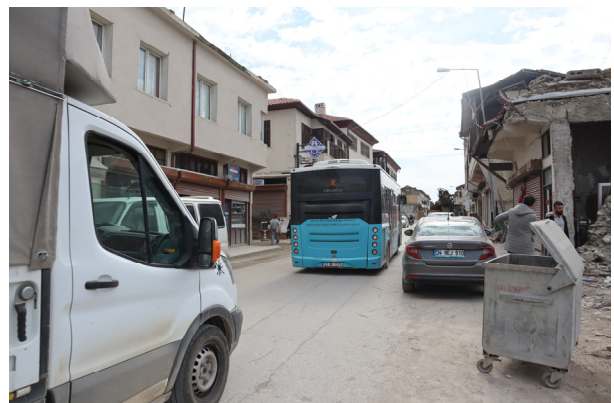
クルトウルシュ通り。交通量が非常に多い。

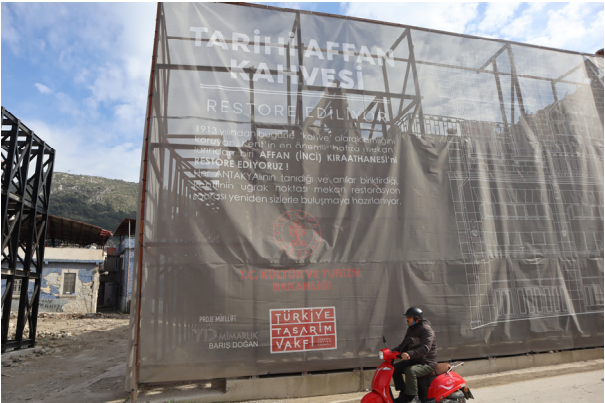
クルトゥルシュ通りの文化財建造物。倒壊しないように鉄骨で支えている。

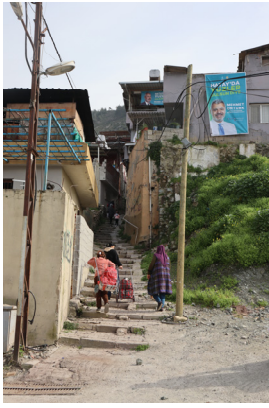
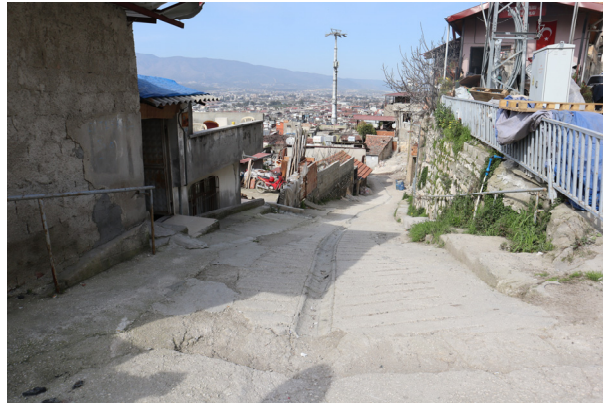
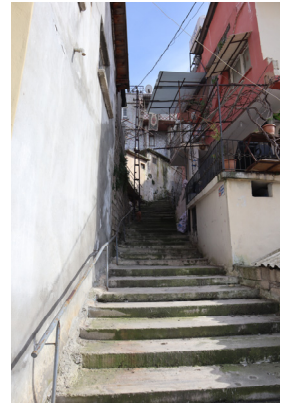
街の様子。地震の影響は見られない。地盤が良いことが要因として考えられる。

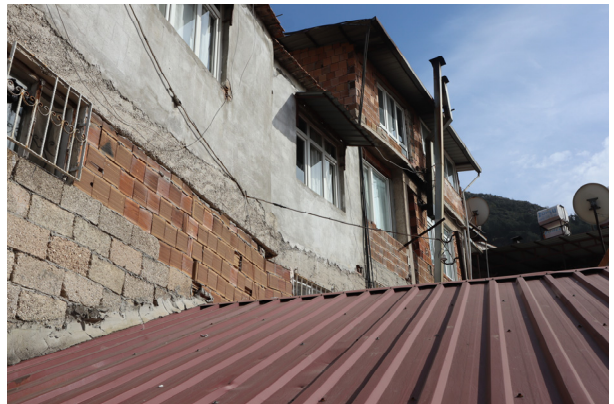
ブロック壁。地震の影響を全く受けていない。

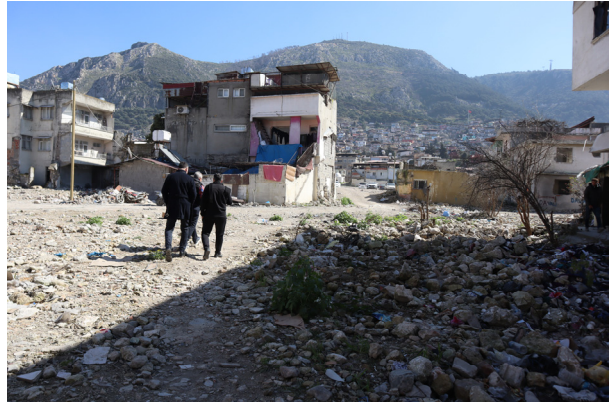
旧市街の様子。更地が目立つ。

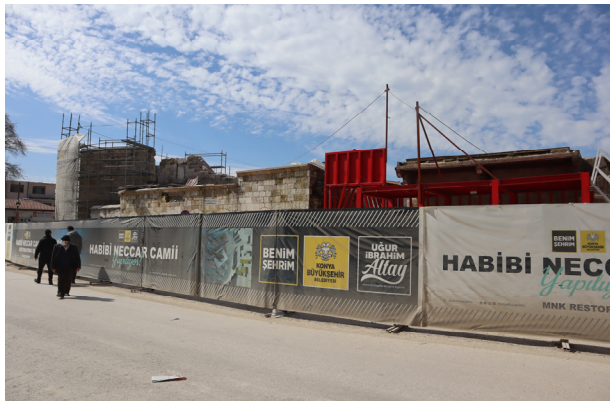
ハビビネッジャールジャーミイ 国主導で復旧・復興が進行中

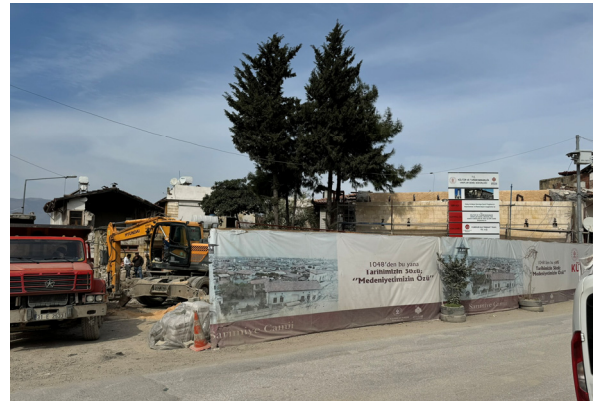
サルミエジャーミイ 国主導で復旧・復興が進行中

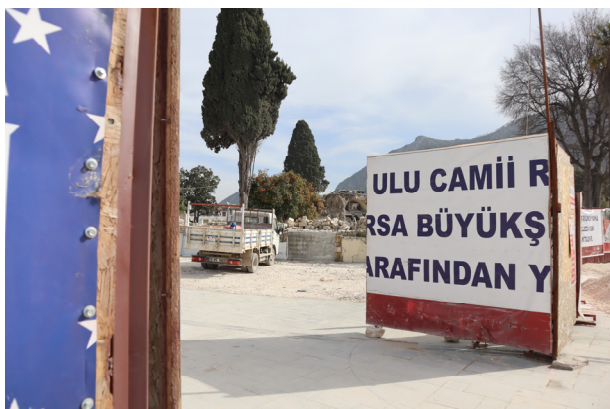
ウルジャーミイ 国主導で復旧・復興が進行中

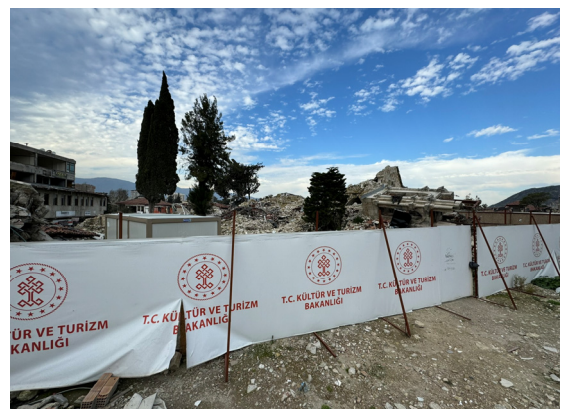
ギリシャ正教会 国によりプロテクトされている

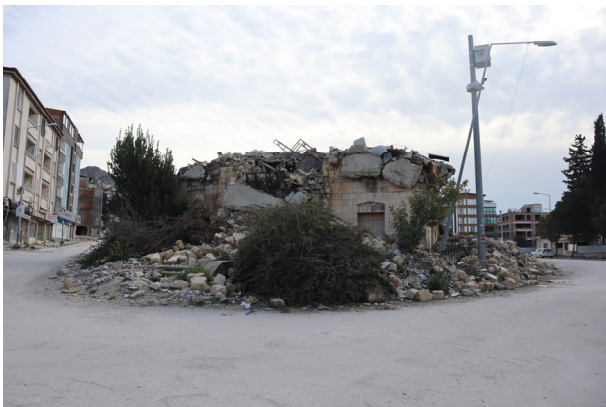
プロテスタント教会 そのまま放置されている

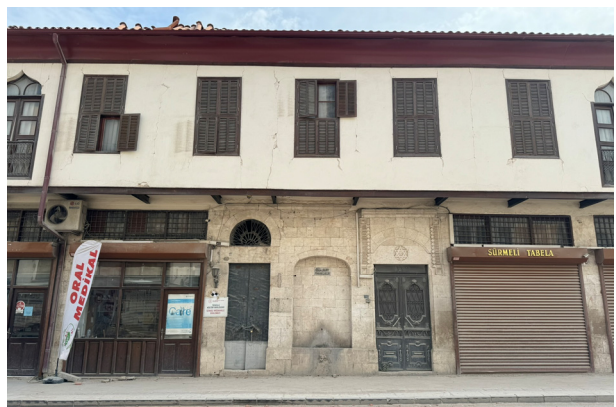
シナゴーク 立ち入り禁止の看板が貼られている

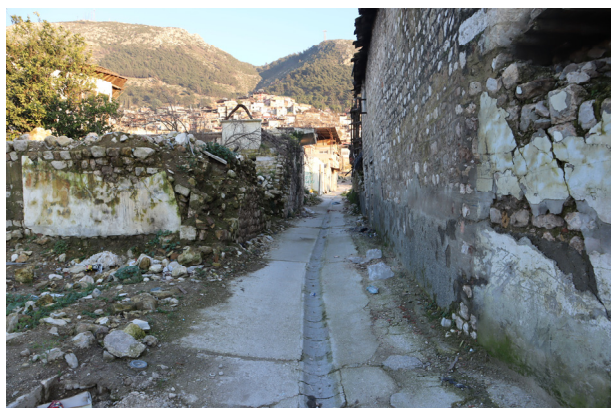
路地空間 真ん中に排水路をとっている

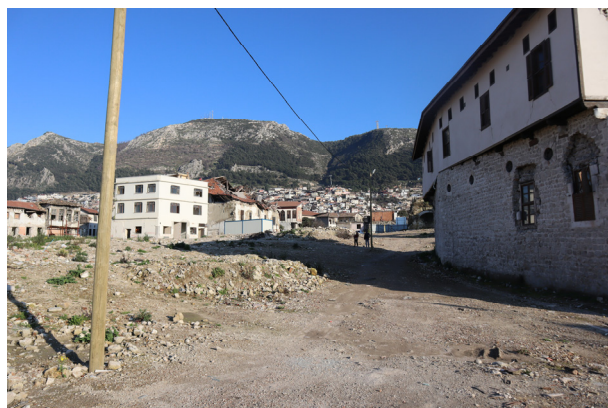
かつては迷路のような路地だったが、今はこのように瓦礫が処理された風景が広がっている

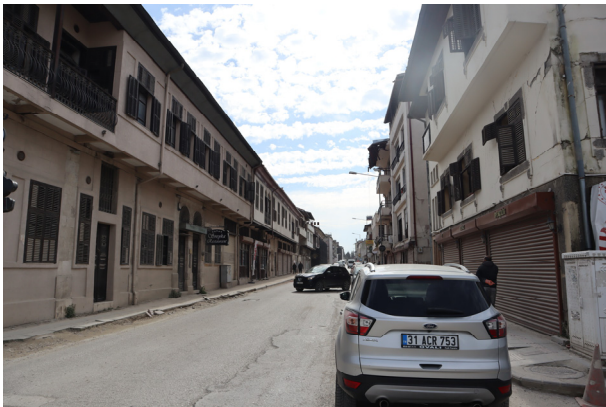
クルトゥルシュ通り

左側はジュンバ等により美しい景観が形成されている  
一方右側は建物の高さが高く、左側の町並みと揃っていない

例えば古代アンティオキアからの歴史を持ち、現代の目抜き通りでもあるクルトゥルシュ通りにおいては、文化財級の建物も多いが、隣接建物や対面建物の連続性や形態的調和の観点から見ると、総じて美観が形成されているとは言い難い。伝統的形態であるジュンバ（上階がキャンティレバーで張り出す）、勾配屋根、赤瓦、3層までの建物高さなどのデザインコードにより、通りに面する両側町並みの連続性を確保することは、都市景観を形成する上で重要なことである。

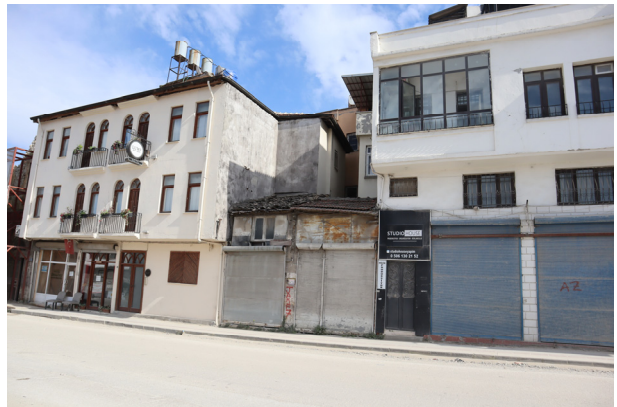
クルトゥルシュ通り

町並みの連続性が途切れている

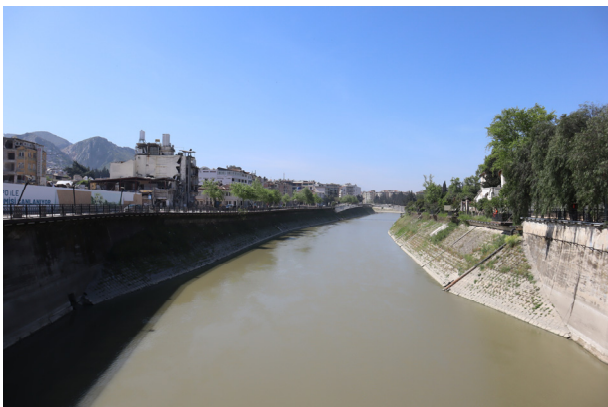
アシ川の景観 親水性が無い

アシ川の親水性を高めると同時に、アシ川から見るハビビネツジャール山の眺望を大切にすると同時に町並み景観を形成できると良い。また橋がある景観も大切である。

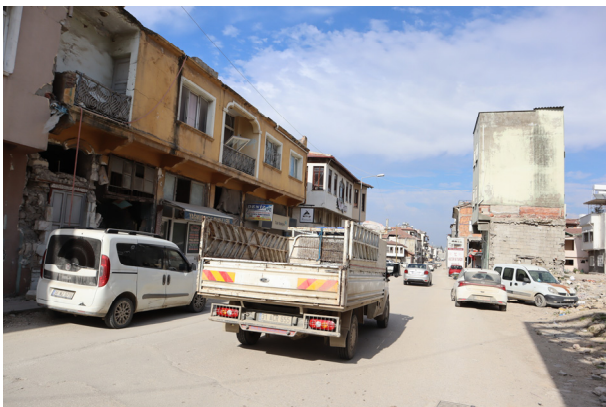
クルトゥルシュ通り 交通量が非常に多い

目抜き通りであるクルトゥルシュ通りの交通量は非常に多い。大型車両も頻繁に往来し、常時、砂埃が舞っていた。この通りを歩行者専用にすることを提案する。クルトゥルシュ通りはウズンチャルシュ（＝ロングバザール）につながる。ウズンチャルシュは現在、少しずつではあるが活気を取り戻している。倒壊したアーケードの復旧・復興も、国主導で進んでいる。そしてウズンチャルシュはヒュリエット通りにつながる。ヒュリエット通りは、現在は壊滅状態だが、かつてはギリシャ正教会の門前町としても賑わいを見せる歩行者専用の通りであった。そこから例えばサライ通りやシラフル・クヴェトゥレシュ通りをとおり、クルトゥルシュ通りに戻る。サライ通りやシラフル・クヴェトゥレシュ通りも歩行者専用とする。旧市街を一周するこの循環路には、アンタキヤの主要なジャーミィ（＝モスク）や教会、シナゴグ等、多くの歴史的建造物が面しており、これらを歩いて巡れるようにすることで、アンタキヤの町の魅力が増すだろう。

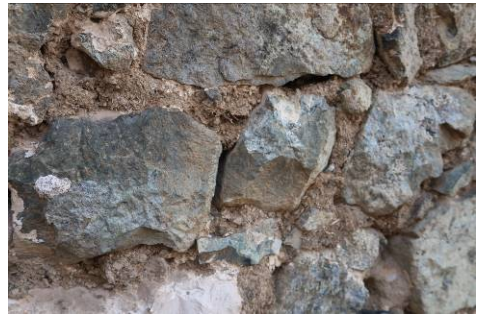
伝統的構法の建物の主な構造は、1層目が無筋の玉石(栗石)組積造で、2層目が瓦葺き Bağdadi 外壁(木軸両面を木摺張りの上漆喰塗りした壁で、木摺間には小石を詰める)の木造軸組である。無筋の玉石(栗石)組積造壁は極めて脆性的であり、微細なひび割れでも耐力低下を生じる。したがって、地震後の残存耐力は、外観からは容易に推定できないと考える。

貧弱なモルタル

An unreinforced rubble stone masonry wall can be regarded as an unreinforced rubble stone concrete wall from a materials engineering perspective. The strength of concrete is determined by the minimum value of the strength of the rubble stone that is the aggregate, the strength of the filled mortar, and the adhesion strength between the aggregate and mortar. However, the mortar used in traditional construction methods is thought to be a lime-based mortar not containing natural pozzolans, which is often found to be fragile in appearance. We believe that the strength of unreinforced rubble stone masonry walls can be easily increased by using current mortar with guaranteed strength or mortar reinforced by mixing Portland cement.

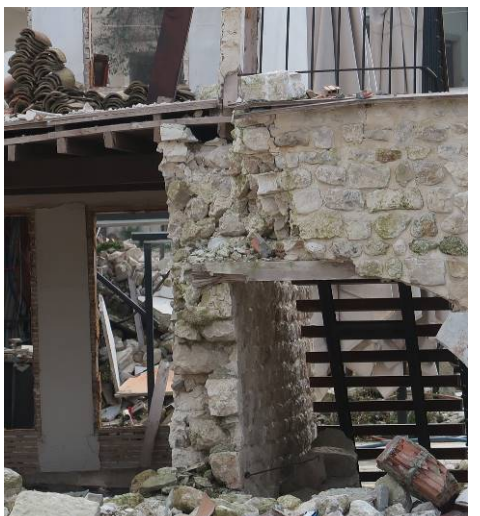
また、組積造壁の天端には木造床組・床板が載っているが、組積造壁の水平剛性に比して、木造床の面内水平剛性は低いと推察される。木造床を無視しても組積造壁が地震水平力に耐えるならば問題ないが、木造床を介して再配分する必要があるならば、十分な面内水平剛性を有する床面が必要となる。床剛性が不足すれば、地震力が再配分される以前に、自立できない組積造壁に損傷を生じ得る。

玉石(栗石)組積壁と木造床

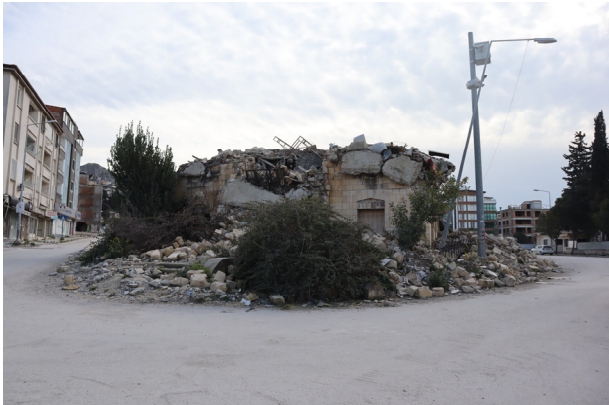
Protestant church Left neglected

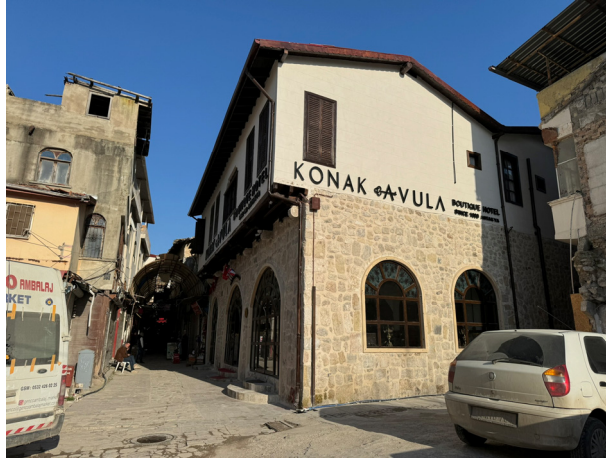
There are examples of buildings renovated by local architects that have not been affected so much by the earthquake. This is probably due to their familiarity with the local climate, materials, craftsmanship, and other factors. In the reconstruction of a townscape, it is important to listen to the opinions of such experienced local architects.

Example of hotel renovation by local architect

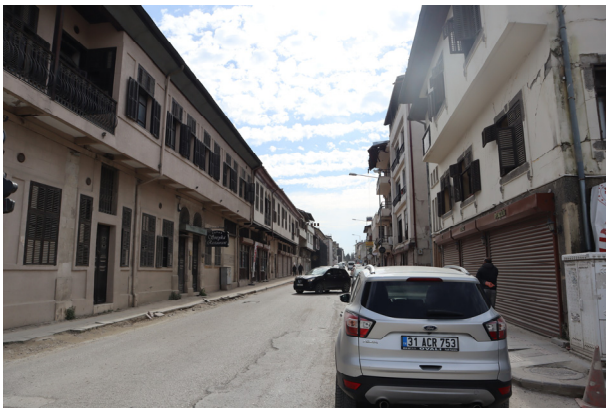
Kurtuluş Street

On the left side, a beautiful landscape is formed by Jumba and other elements

On the other hand, the buildings on the right are taller and are not aligned with the townscape on the left

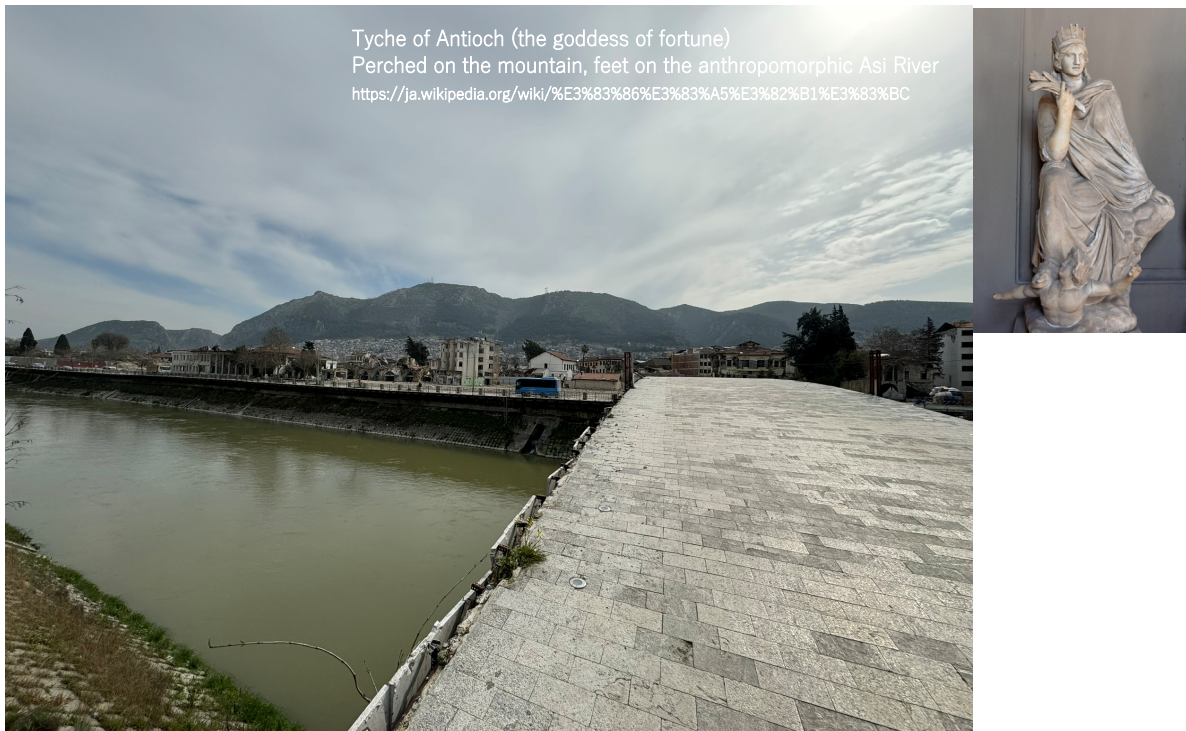
Asi River and Habib-i Nejjar Mountain

It would be good to improve Asi River hydrophilicity and simultaneously shape the townscape in a way that emphasizes the view of Habib-i Nejjar Mountain from the Asi River. In addition, landscapes with bridges are important.

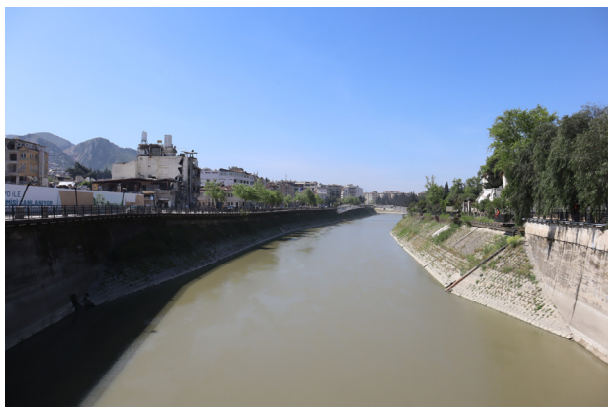
However, at present, the banks of the Asi River are hardened with concrete, and it has not been possible to improve their hydrophilicity. It would be good to improve Asi River hydrophilicity and simultaneously shape the townscape in a way that emphasizes the view of Habib-i Nejjar Mountain from the Asi River. In addition, landscapes with bridges are important. Currently, reconstruction work is underway on housing complexes along the river on the new city side, and it would be nice to be able to preserve the views of the Asi River and Habib-i Nejjar Mountain here as well. A west mountain seen from the old city is also beautiful. In the future, as buildings are being restored and reconstructed, viewpoints offering views of the west mountain in the old city should be secured.

Asi River landscape No hydrophilicity

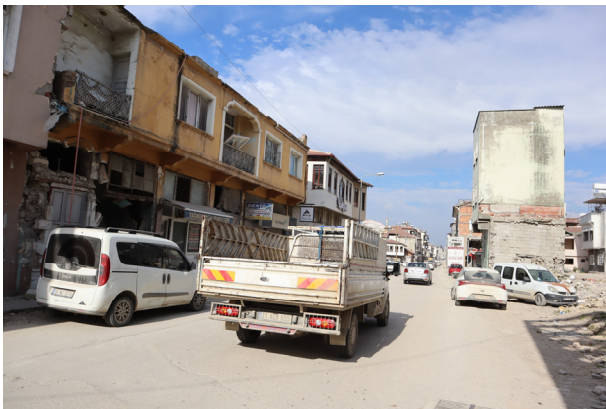
The main street, Kurtuluş Street, has a heavy traffic volume. Large vehicles frequently come and go, and dust is constantly flying around. We propose making this street pedestrian-only. Kurtuluş Street leads to Uzun Çarşı (Long Bazaar). Uzun Çarşı is currently regaining its vitality, albeit little by little. Restoration and reconstruction of the collapsed arcade is also progressing under the government's initiative. Then, Uzun Çarşı connects to Hürriyet Street, which is now in a state of disrepair but was once a busy pedestrian-only street that served as a temple town for the Greek Orthodox Church. From there, for example, it passes through Saray Street and Silahlı Kuvvetler Street and then returns to Kurtuluş Street. Let us assume that Saray Street and Silahlı Kuvvetler Street are also pedestrian-only; this circulation route would go around the old city, encountering many historical buildings such as Antakya's main Cami (mosque), churches, and the synagogue, making it possible to walk around them and thereby increasing Antakya's charm

Kurtuluş Street Very heavy traffic

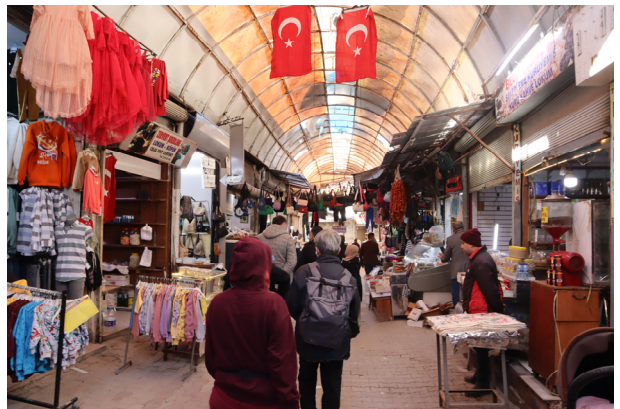
Uzun Çarşı Regaining its vitality little by little

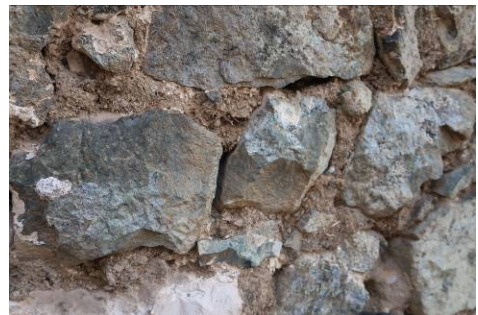
Poor mortar
